# INSPECTION REPORT

**746 Sample Avenue**

### INSPECTION REPORT

746 Sample Avenue, St. Paul, MN

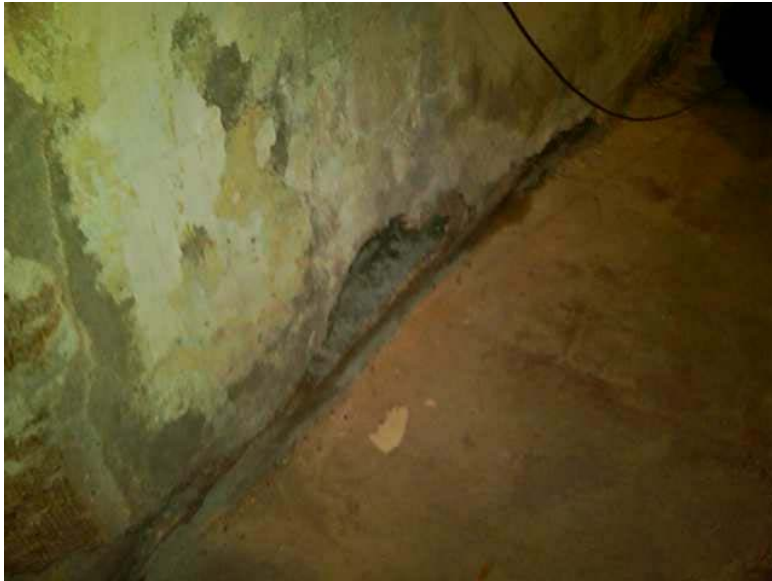
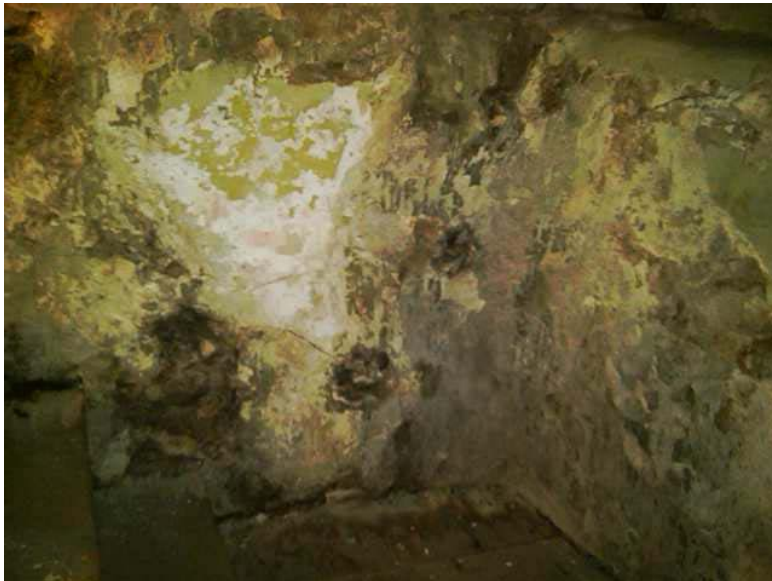
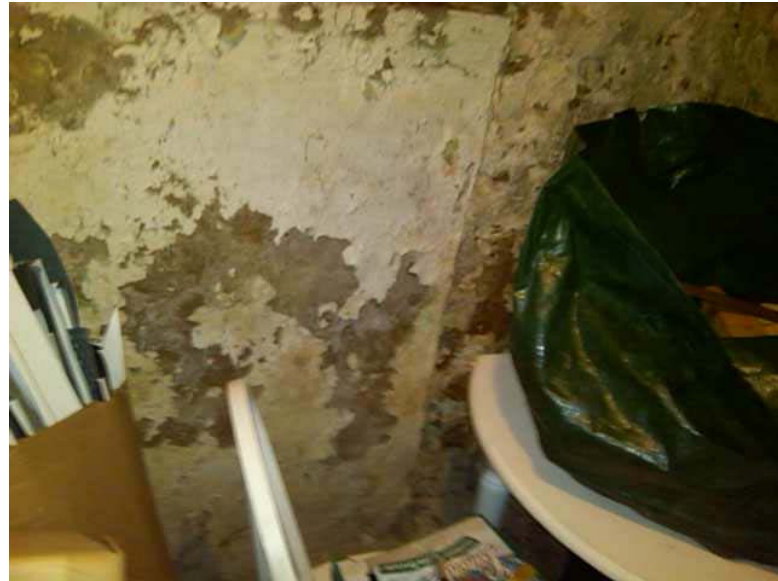
**Foundation**

- 1.5 Foundation Significant spalling and damaged back plastering due to moisture penetration, missing mortar between stones. Not visible in all areas due to old back plastering. Recommend consulting with a stone foundation specialist regarding tuck-pointing repairs.

Significant spalling and damaged back plastering due to moisture penetration, missing mortar between stones. Not visible in all areas due to old back plastering. Recommend consulting with a stone foundation specialist regarding tuck-pointing repairs.

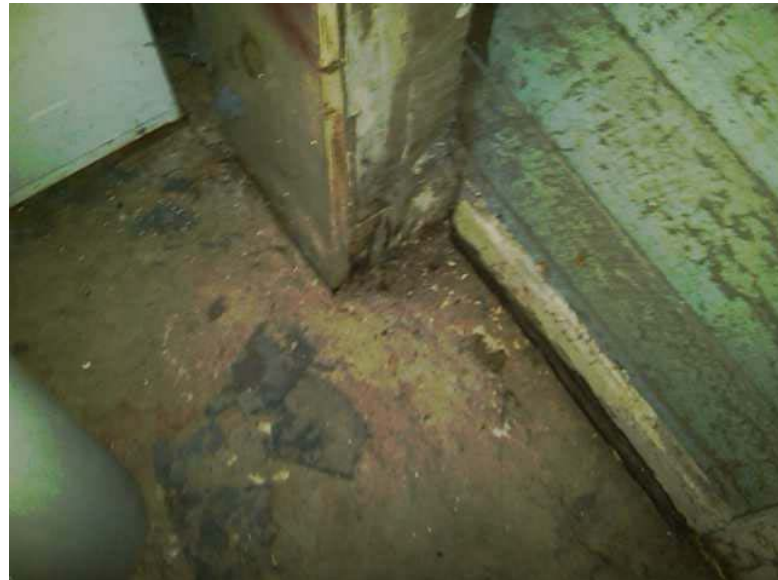
**Posts/Columns**

1. 8.00 Posts/Columns	<i>Wood</i>	<i>Decay noted to the bottom of the posts.</i>	<b>MARGINAL</b>

Decay noted to the bottom of the posts.

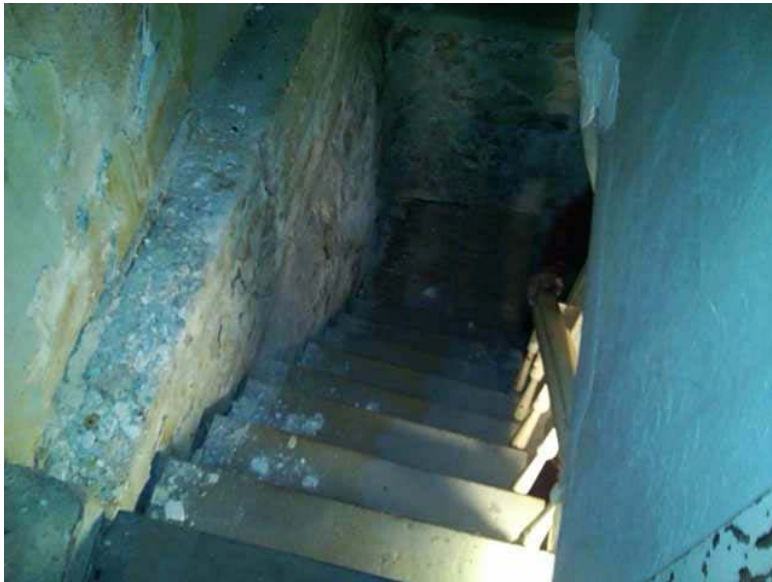
**Stairs and Railings**

Low headroom - less than 6'8" headroom. Improper / uneven stair rise. Improper stair tread run. Narrow staircase (less than 36 inches wide). Lacks a proper handrail.

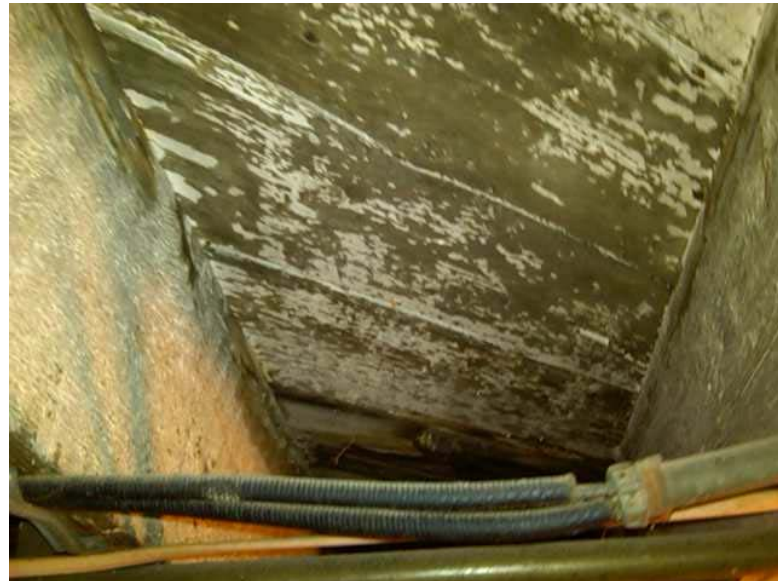
**Subflooring**

Chipped and peeling paint on subflooring. Stains noted on subflooring in areas (most noted near plumbing).

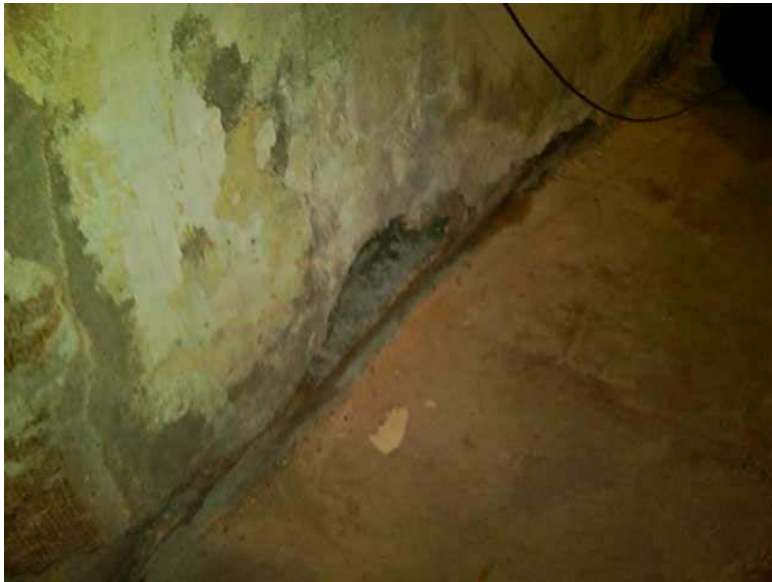
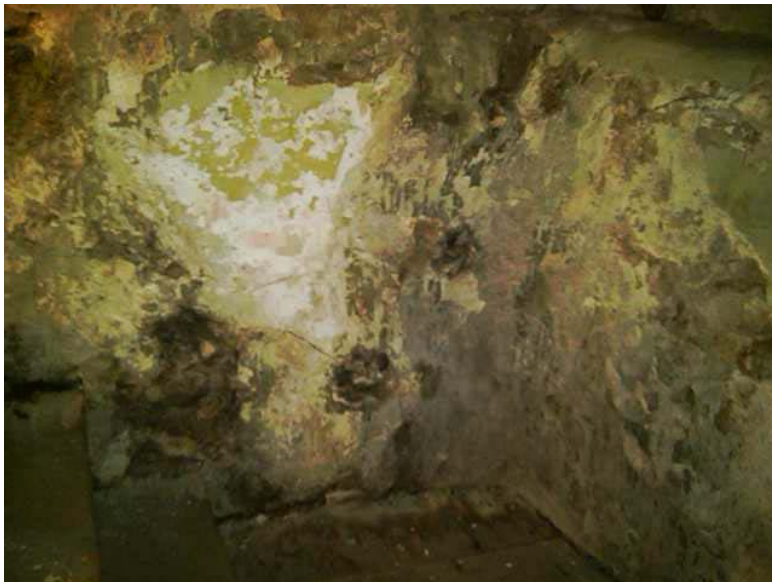
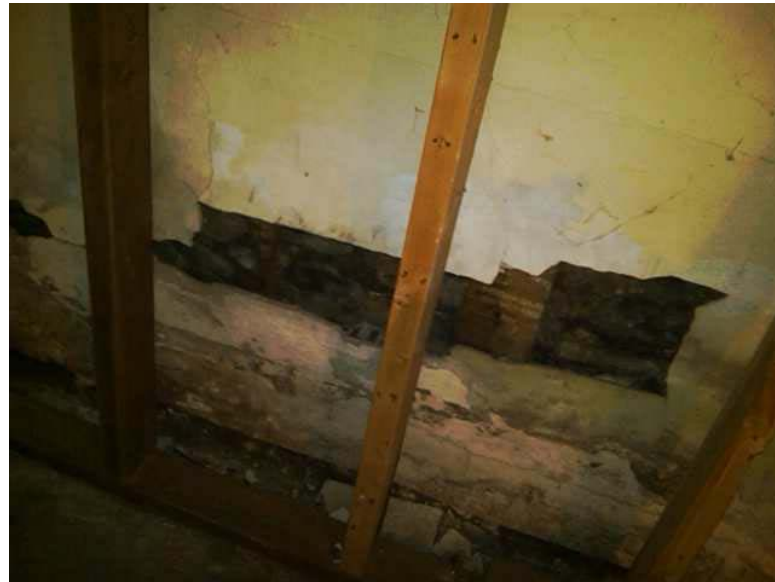
**Signs of Moisture**

- 1.12 Signs of Moisture This basement has experienced moisture penetration. Evidence of past seepage noted at - outer walls (stains/efflorescence, spalling finish, mold and mildew). Recommend increasing the grade at all low to flat areas to help direct moisture away from the foundation.

This basement has experienced moisture penetration. Evidence of past seepage noted at - outer walls (stains/efflorescence, spalling finish, mold and mildew). Recommend increasing the grade at all low to flat areas to help direct moisture away from the foundation.

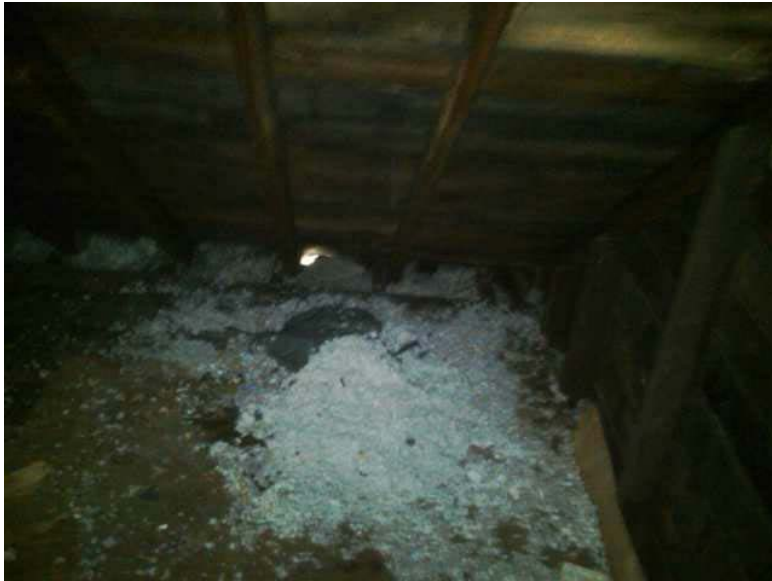
**Roof Sheathing**

Past staining noted on roof sheathing. Signs of past fire - charring.

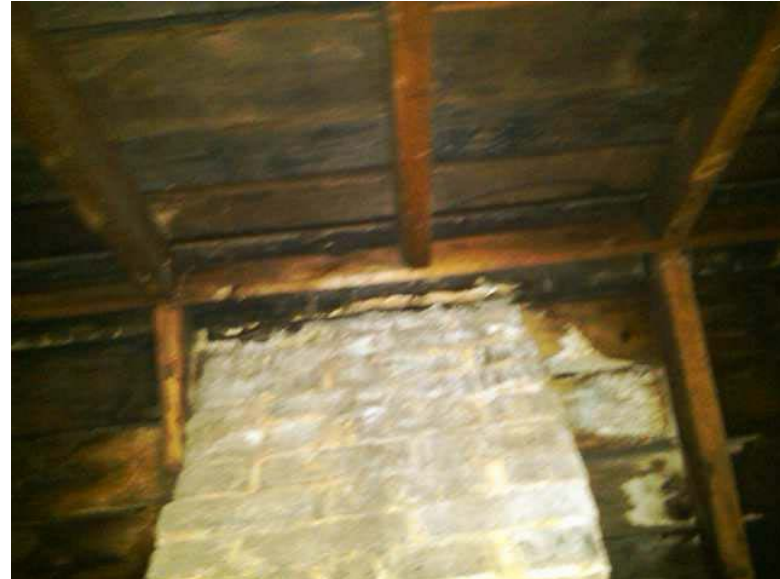
**Chimney or Vent in Attic**

Past stains noted around chimney hole on sheathing and wood members.

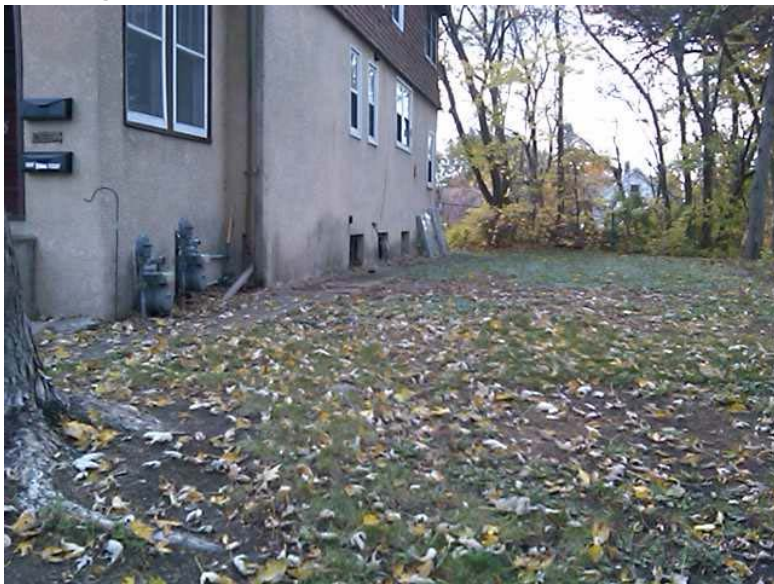
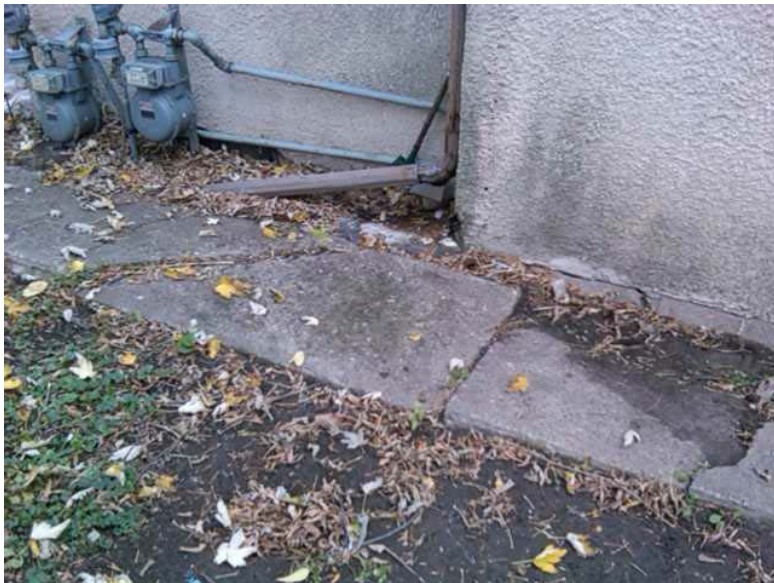
**2.1 EXTERIOR**  
**Drainage, Grade, & Slope**

- 2.1 Drainage, Grade, & Slope Flat areas close to structure. The grade in areas does not allow surface water to drain away from the foundation. Evidence of significant moisture penetration in basement - Consideration should be made to increasing the grade at all low to flat areas to help direct moisture away from the foundation.

Flat areas close to structure. The grade in areas does not allow surface water to drain away from the foundation. Evidence of significant moisture penetration in basement - Consideration should be made to increasing the grade at all low to flat areas to help direct moisture away from the foundation.

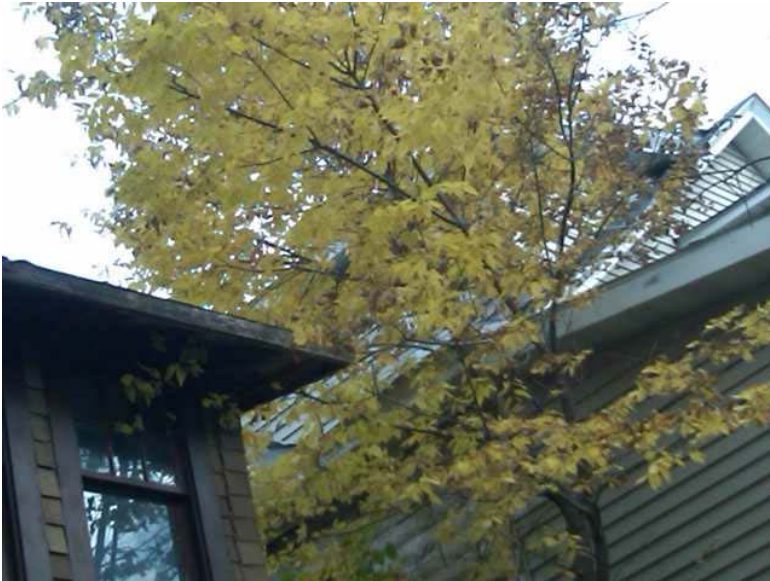
**Plants, Shrubs, & Trees**

Tree branches close to or in contact with the structure. Recommend trimming all branches back.

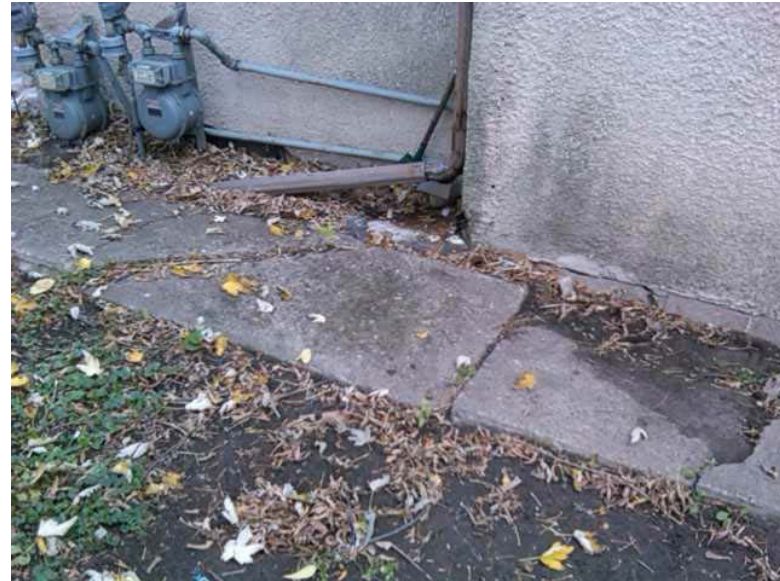
**Walks**

Cracked and settled walks. Sloping toward structure in areas. Recommend budgeting for future repairs/maintenance/replacement

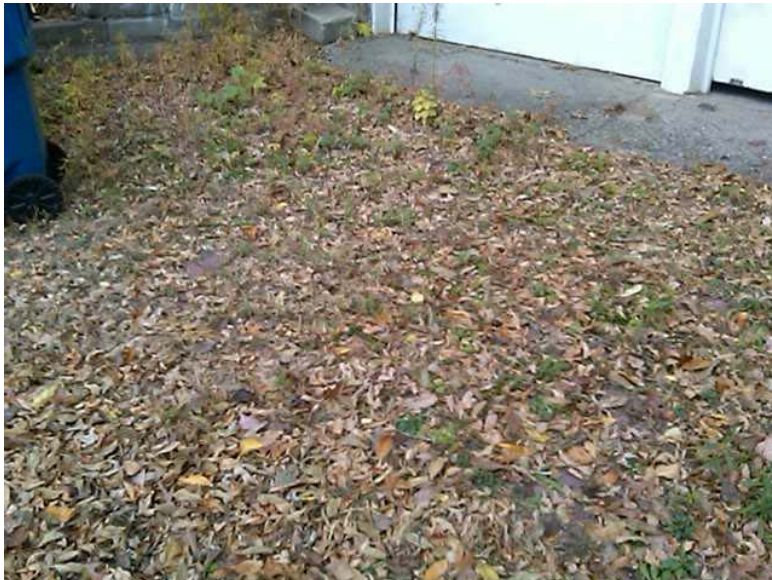
**Driveway(s)**

Low settled areas. Cracked and settled brick, weed growth throughout.

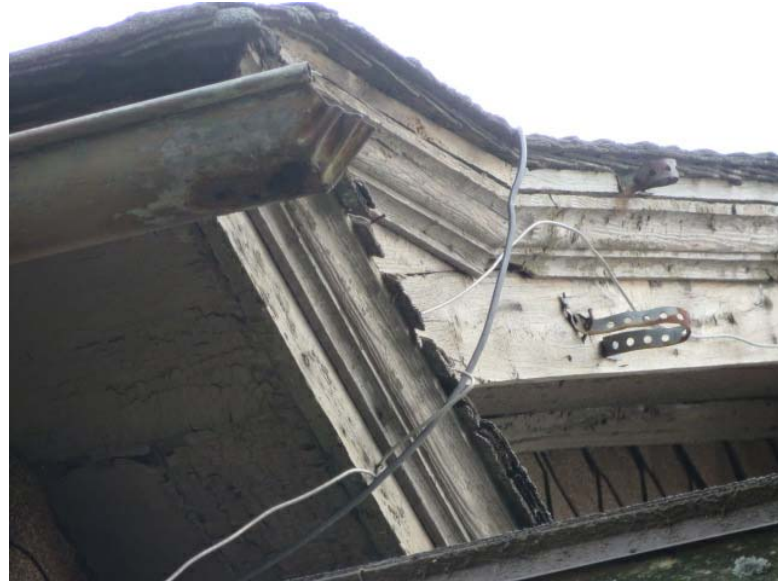
**Soffit & Fascia**

- 2.7 Soffit & Fascia Holes in fascia (light can be seen in attic). Weathered wood components. Chipped and peeling paint. Some - Decayed soffit(s) and fascia. Wood components lack a protective finish. Recommend budgeting for future repairs/replacement.

Holes in fascia (light can be seen in attic). Weathered wood components. Chipped and peeling paint. Some - Decayed soffit(s) and fascia. Wood components lack a protective finish. Recommend budgeting for future repairs/replacement.

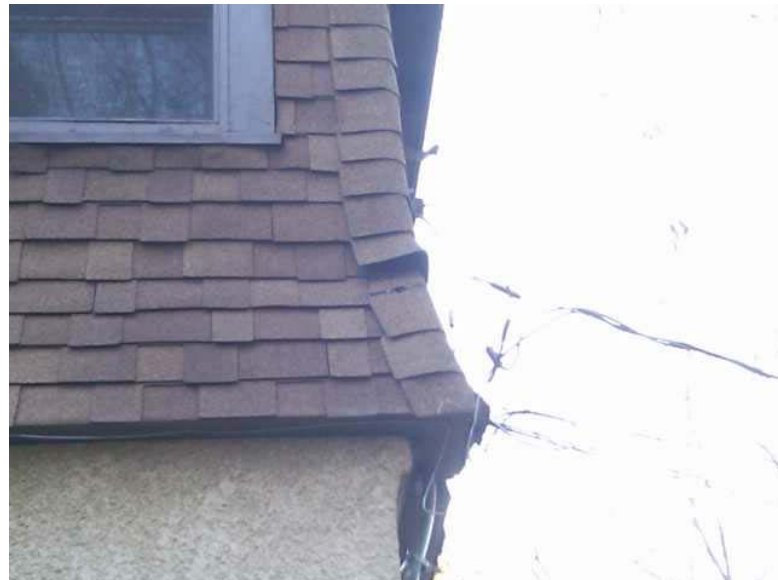
**Wall Cladding**

Stucco exterior. Cracks in stucco finish in areas. Recommend sealing all cracks to deter moisture penetration.

Asphalt Siding: Loose and damage and missing siding in areas. Recommend

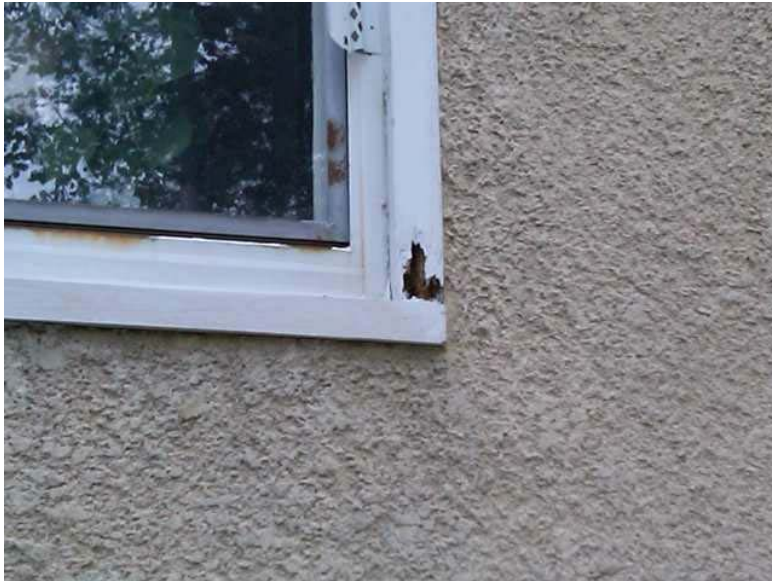
**Windows**

- 2.11 Windows Old wood double hung windows. Chipped and peeling paint. Weathered window components. Decayed trim components. Loose and missing window putty. Windows lack a protective finish. Recommend budgeting for future repairs/maintenance.

Old wood double hung windows. Chipped and peeling paint. Weathered window components. Decayed trim components. Loose and missing window putty. Windows lack a protective finish. Recommend budgeting for future repairs/maintenance.

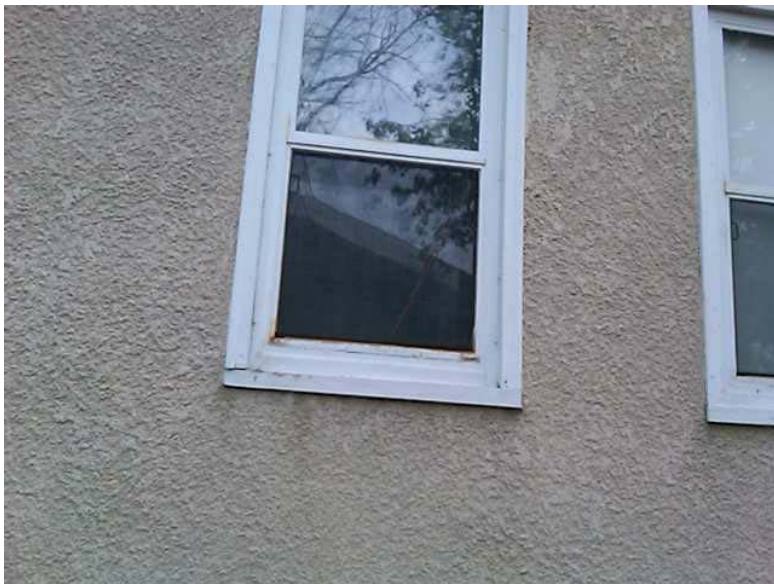
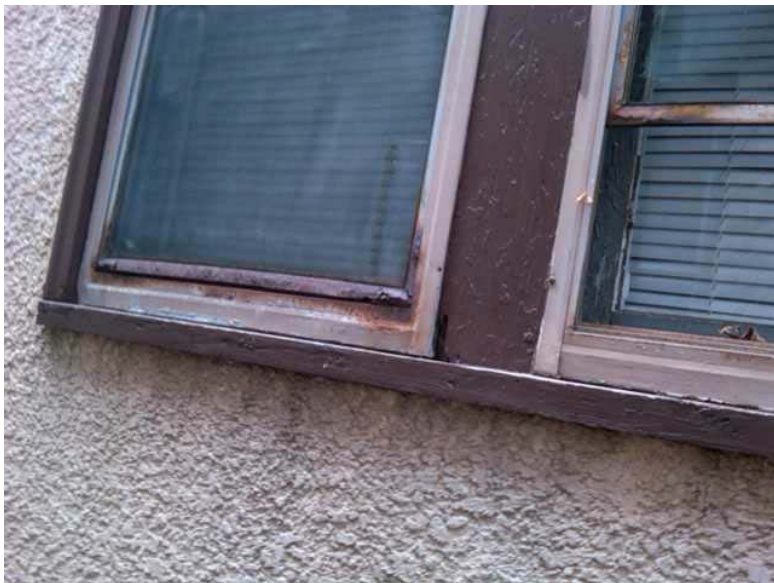
**2.12 EXTERIOR**  
**Storms & Screens**

- 2.12 Storms & Screens Rusty frames, damaged screens, missing screens, Recommend budgeting for future repairs/maintenance.

Rusted frames, damaged screens, missing screens, Recommend budgeting for future repairs/maintenance.

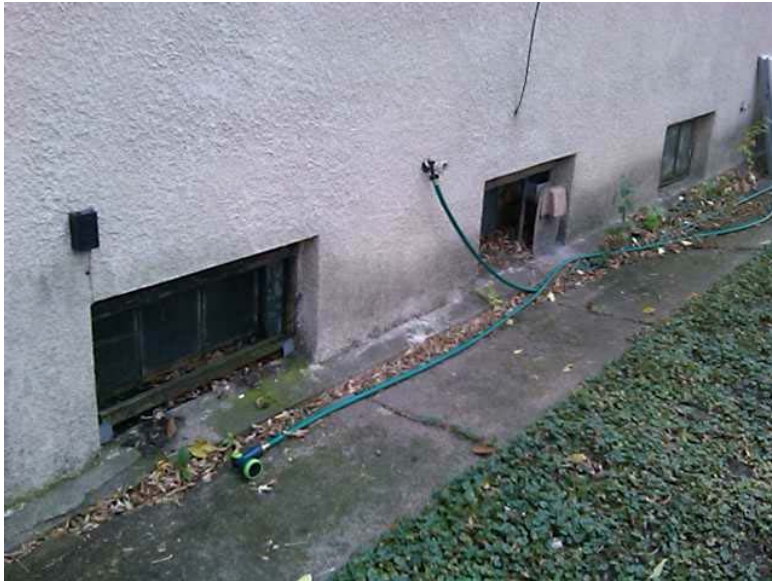
- 2.13 Basement Windows Decayed frame(s) / sill(s). Decayed and damaged components, Chipped and peeling paint. Windows lack protective finish. Some opens have been boarded over (holes).

Decayed frame(s) / sill(s). Decayed and damaged components, Chipped and peeling paint. Windows lack protective finish. Some opens have been boarded over (holes).

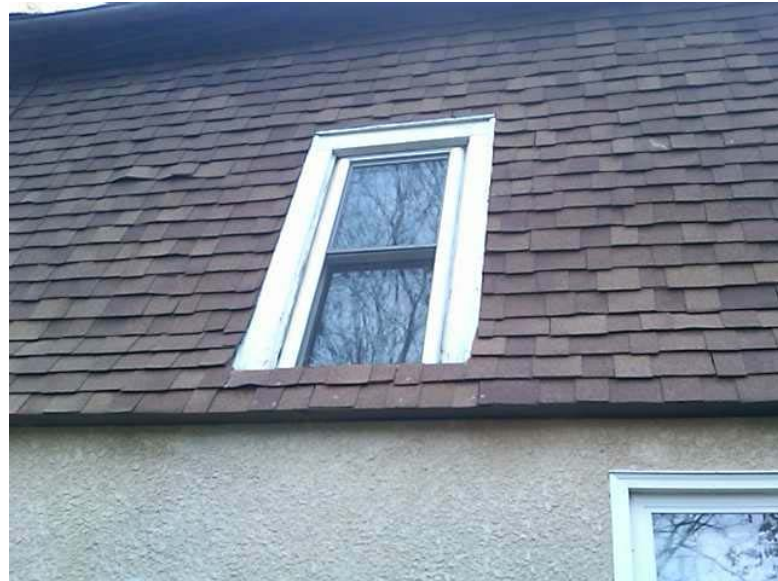
**Trim**

- 2.15 Trim Decayed trim. Holes in trim. Chipped and peeling paint. Weathered wood components. Trim lacks a protective finish in areas. Recommend budgeting for repairs/maintenance.

Decayed trim. Holes in trim. Chipped and peeling paint. Weathered wood components. Trim lacks a protective finish in areas. Recommend budgeting for repairs/maintenance.

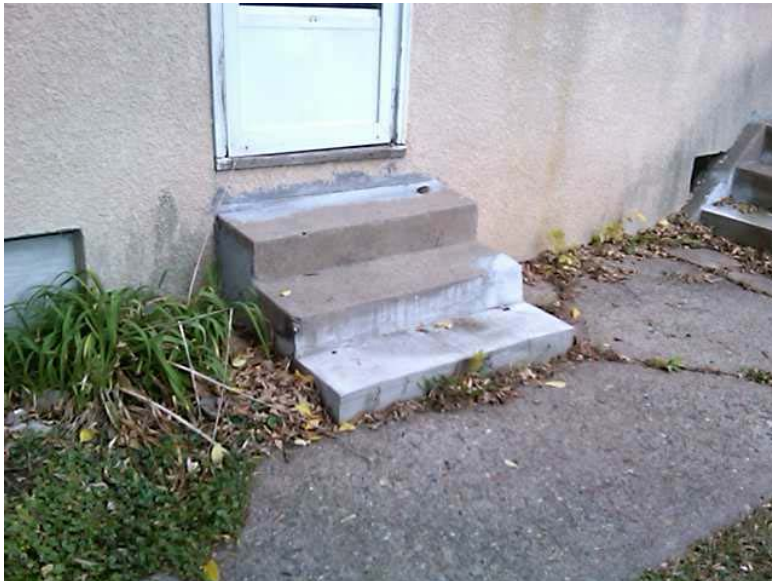
Stoops & Stairs

Improper uneven stair rise (over 8" rise)  
Rear staircase to garage - handrail does not cover all steps, lacks proper  
guardrail on open side.

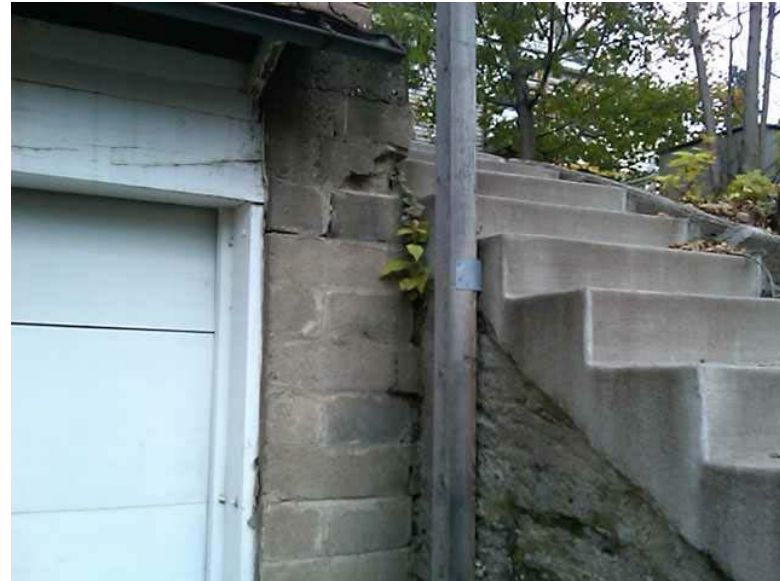
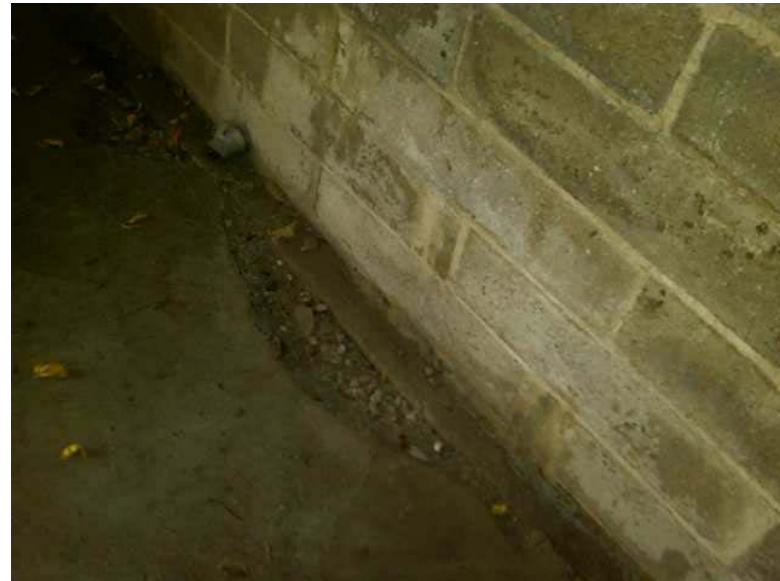
**2.22 EXTERIOR**  
**Garage Walls/Firewalls**

Cracks and past staining on wall components. Decayed shingles and wood on garage exterior. Signs of past moisture on interior garage masonry walls due to poor grade.

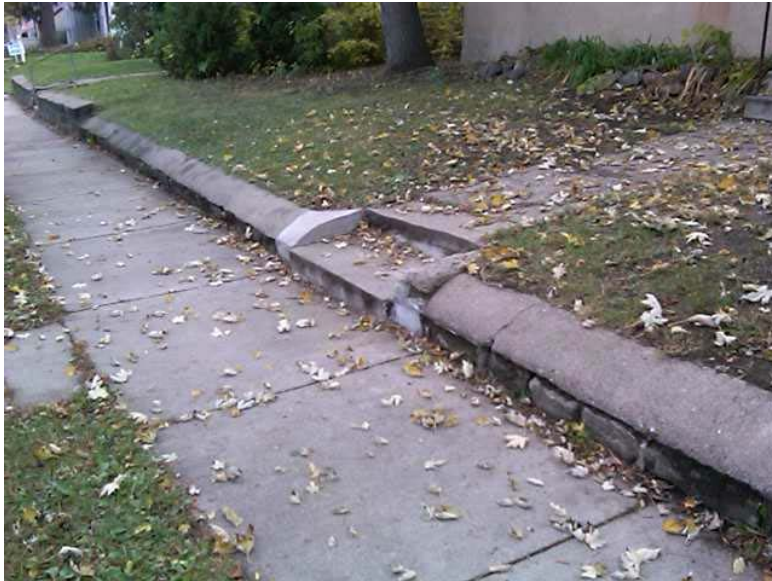
**2.25 EXTERIOR**  
**Retaining Walls**

Retaining walls cracked. Significant cracks in wall at rear of lot and the west side of lot.

Front walls - cracked and deteriorated concrete.

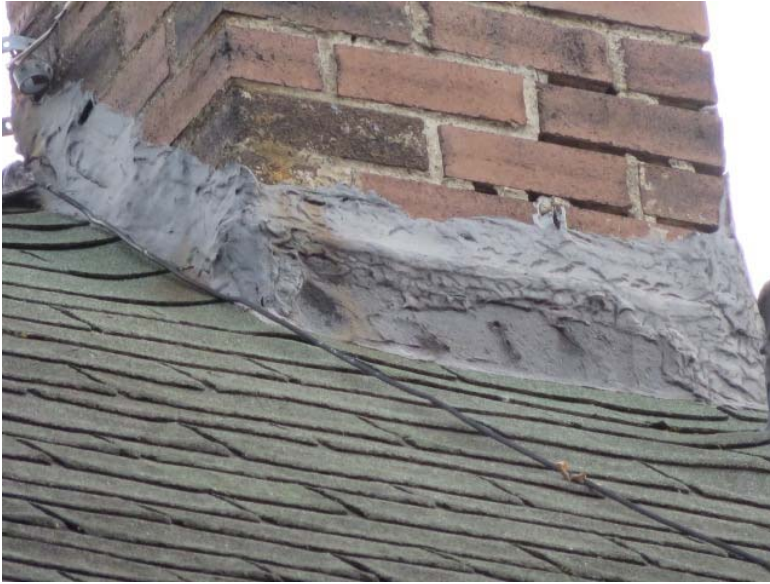
**3.6 ROOF SYSTEM**  
**Chimney(s)**

Missing mortar in joints. Recommend re-tuckpointing the chimney.

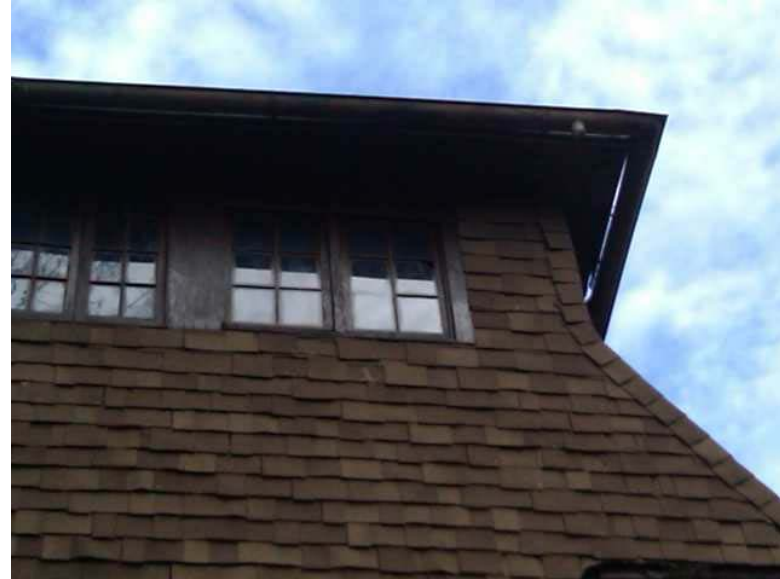
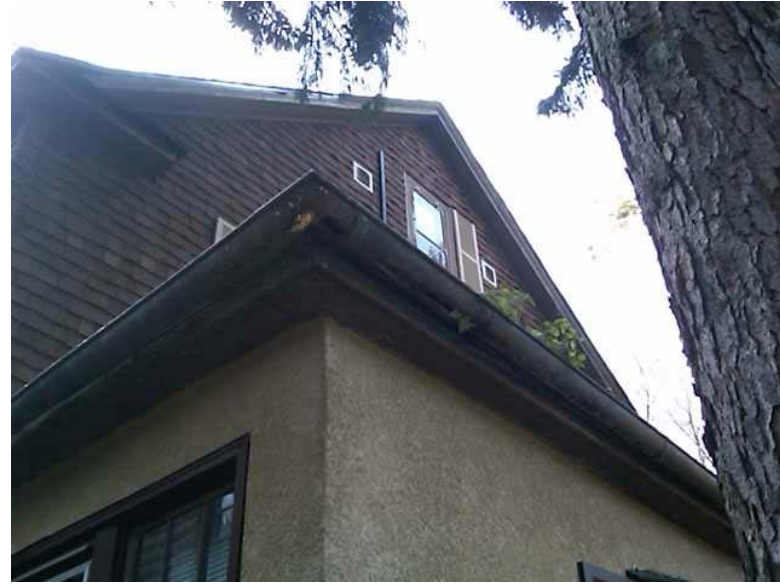
**3.8 ROOF SYSTEM**  
**Gutters**

Bent and damaged gutters, Improperly pitched gutters. Holes in gutters. Rusty gutters. Missing components.

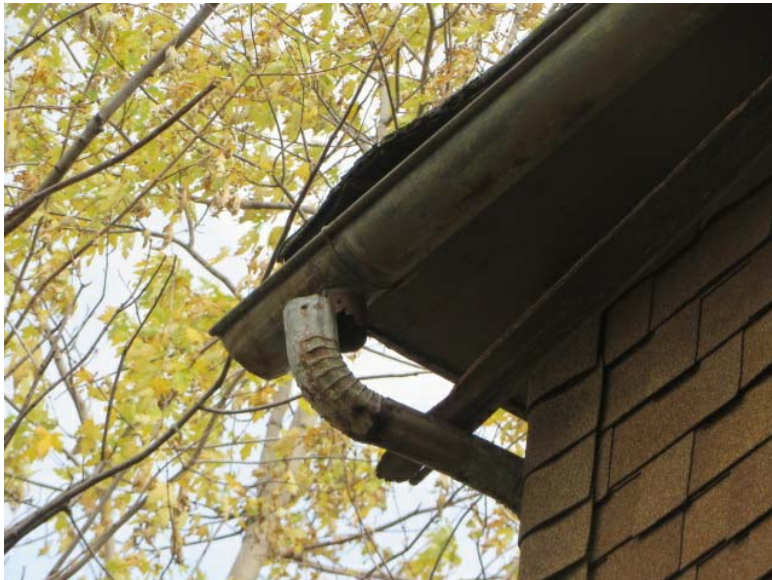
**Downspouts**

Rusted / holes. Missing components. Downspouts are not connected to gutters.

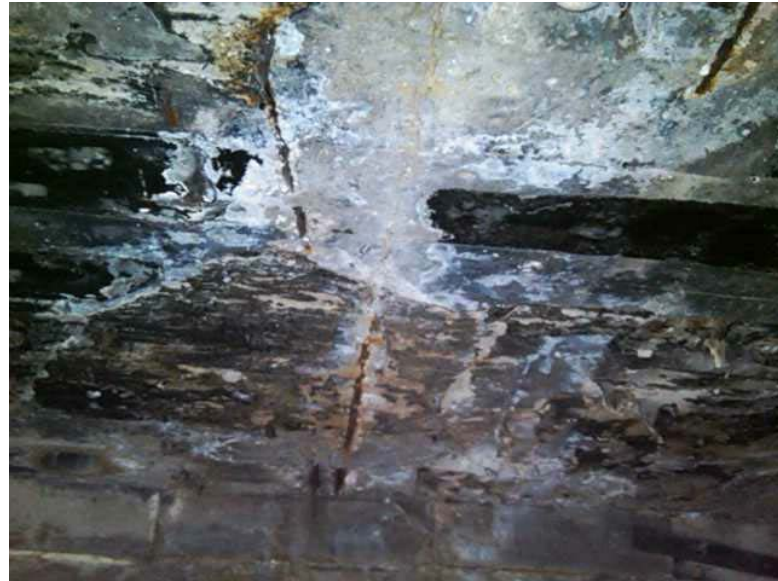
**Garage Roof Structure**

Cracked concrete, rusted re-bar noted in ceiling. Recommend consulting with a Licensed Contractor.

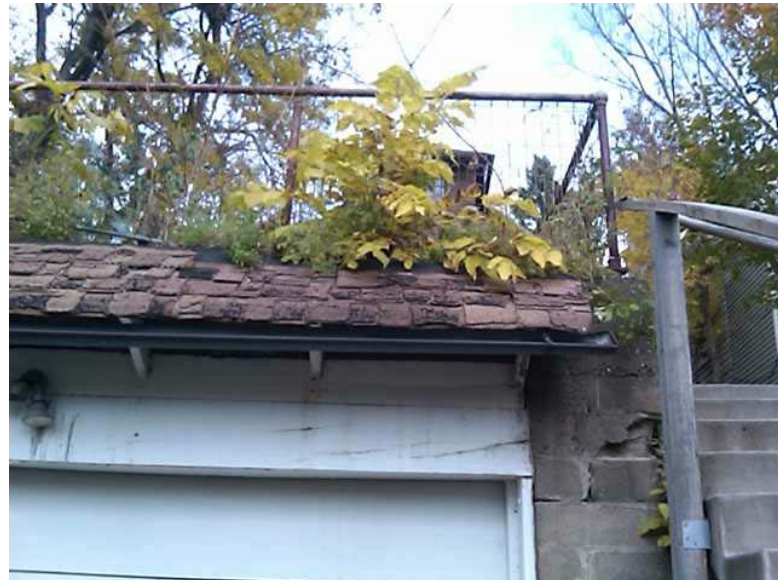
**Garage Roofing**

Deteriorated shingles at roof edge, roof surface was covered with Foliage.

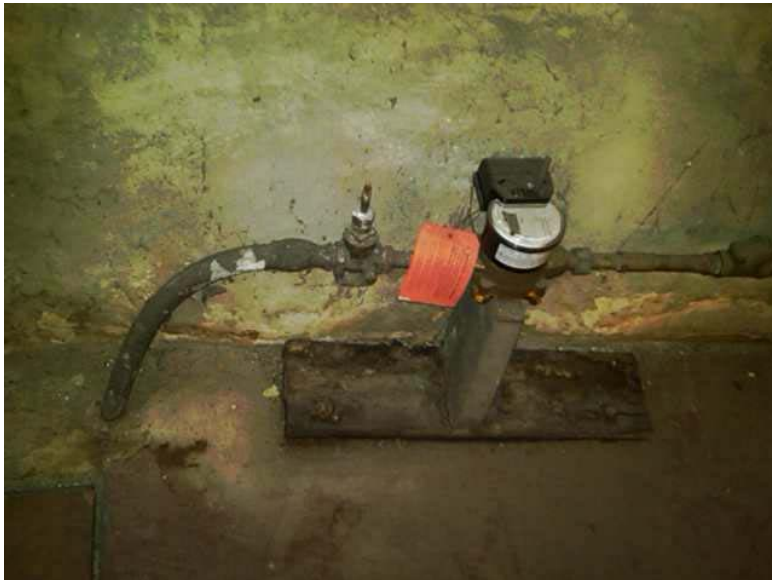
**Main Shut-off Valve**

Damaged / missing handle.

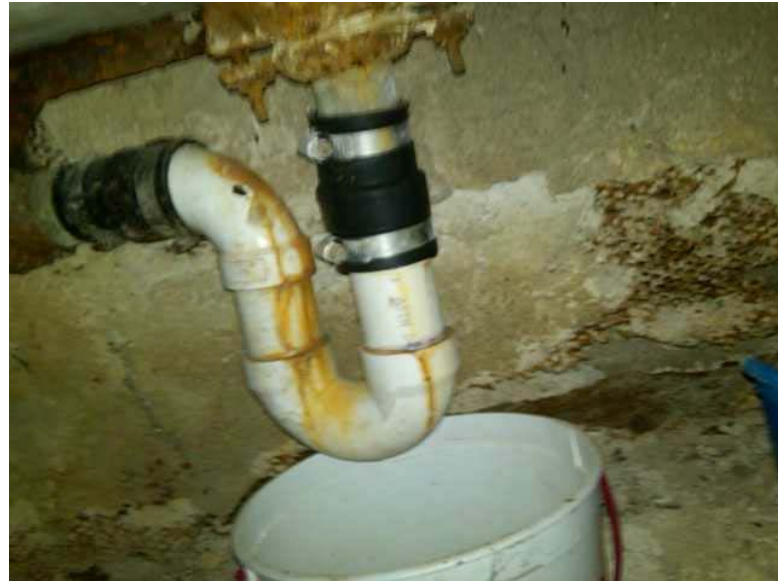
**Waste & Vents**

Unable to view all vent and drain piping for basement fixtures due to finished surfaces. Corroded joints.  
Long trap weir at laundry tub, Improper mission coupling - (lacks a stainless steel collar) at waste assembly.

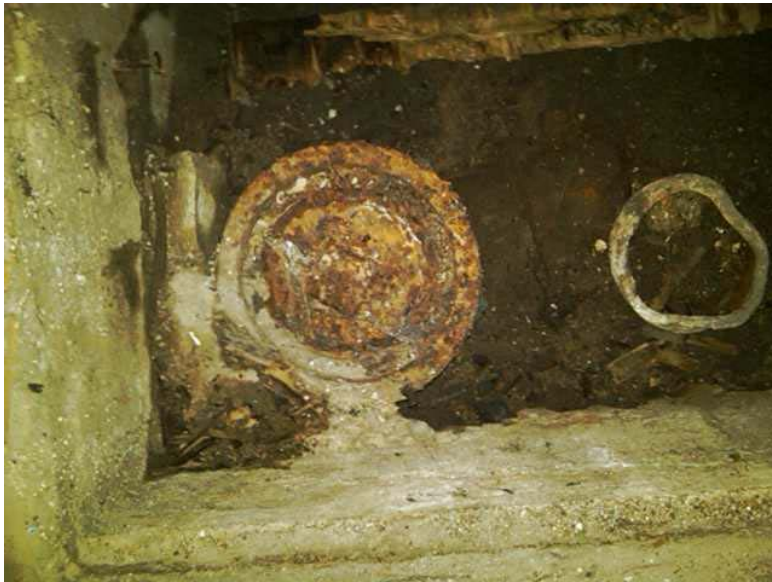
Main Cleanout

Recommend inquiring from the Sellers if they have had any main drain problems in the past (tree roots, water back up from the street).

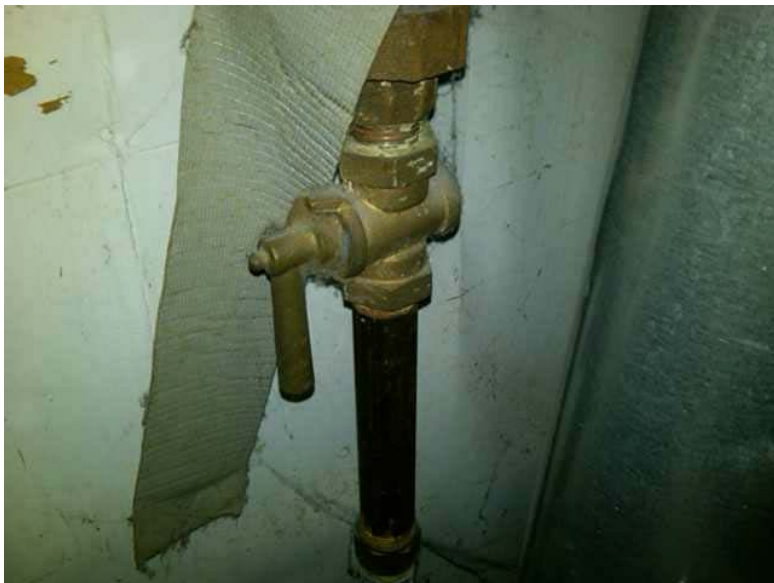
**Fuel Lines**

Unapproved gas valves at dryer - Recommend changing to an approved gas shut off valve at next appliance change out.

Lacks a gas shut off at the Richmond water heater.

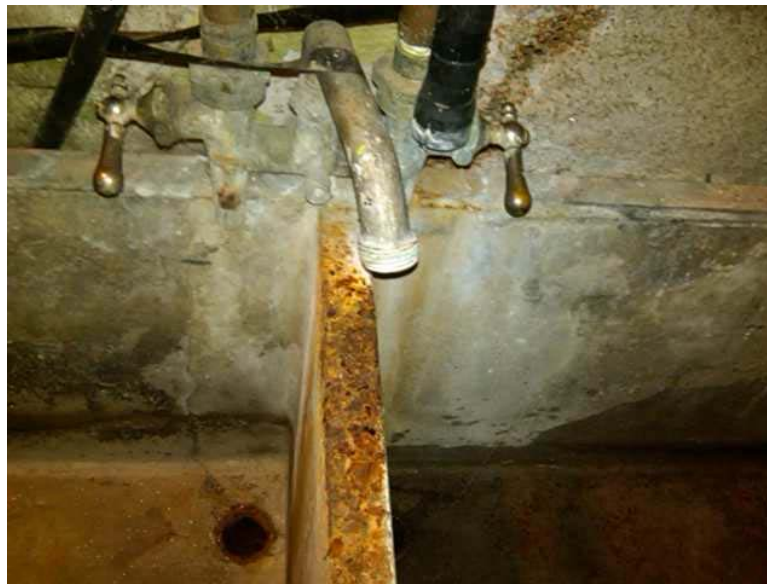
**Laundry Connections**

Cracked cast iron laundry tub, Improper drain assembly. No backflow preventer on threaded taps.

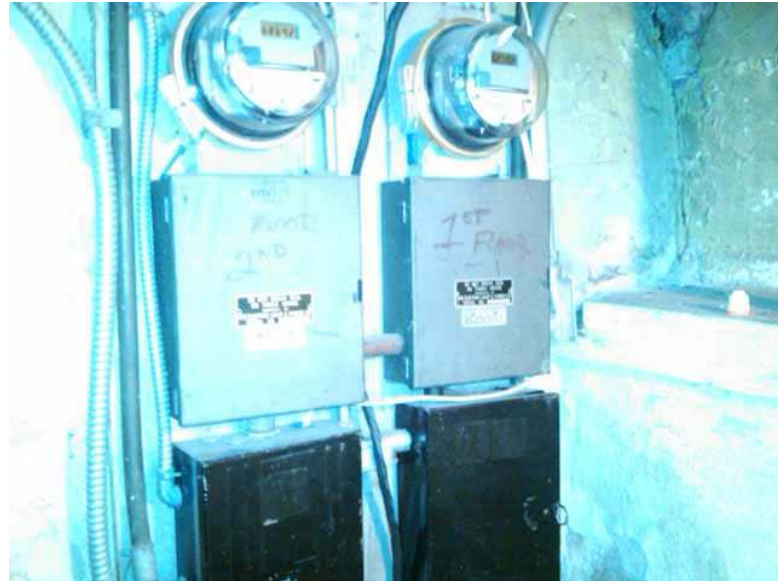
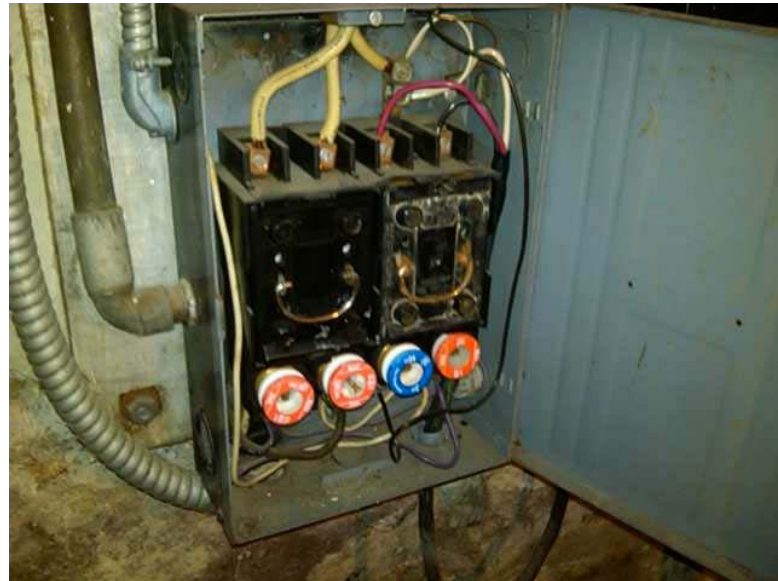
**5.4 ELECTRICAL SYSTEM**  
**Service Panel**

Some circuits not indexed - recommend checking all indexing.

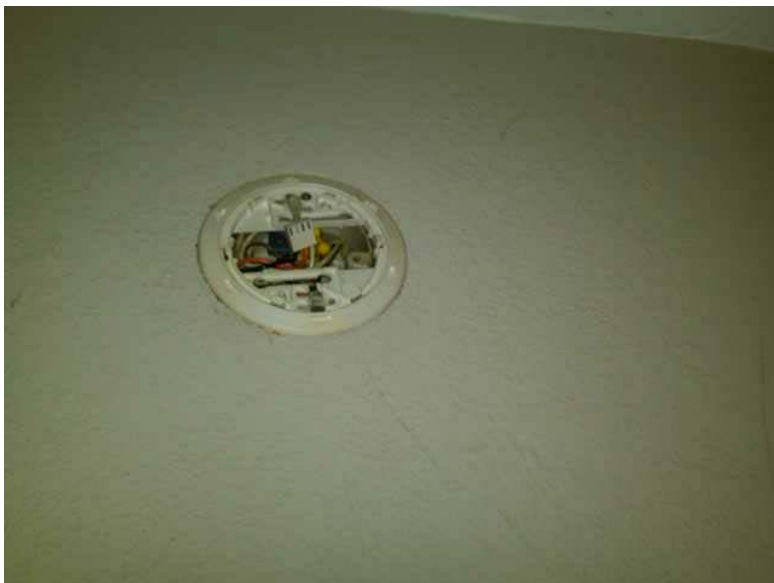
Electrical

Lower Unit: Missing hardwired smoke alarm.

Upper Unit: Rear staircase - lights hanging by wires, Ungrounded 3 prong outlet(s). Missing smoke alarm, Lacks Carbon Monoxide Detectors one at least 10 feet from bedrooms.

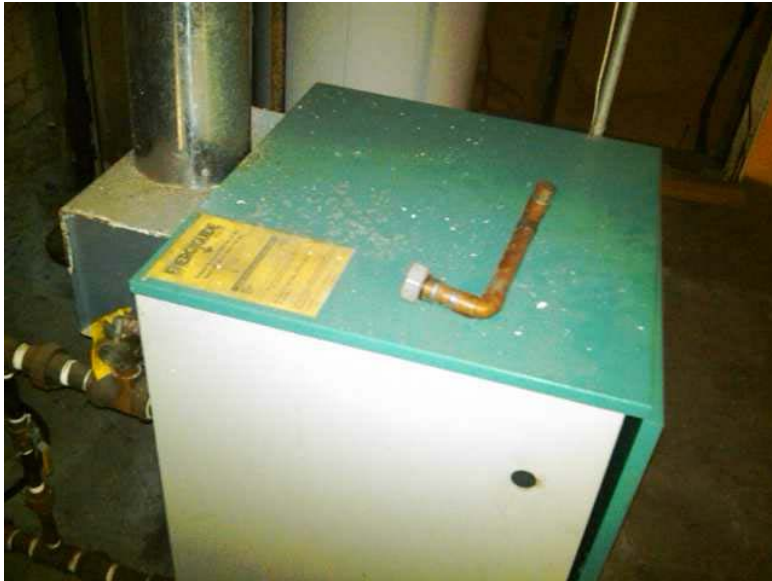
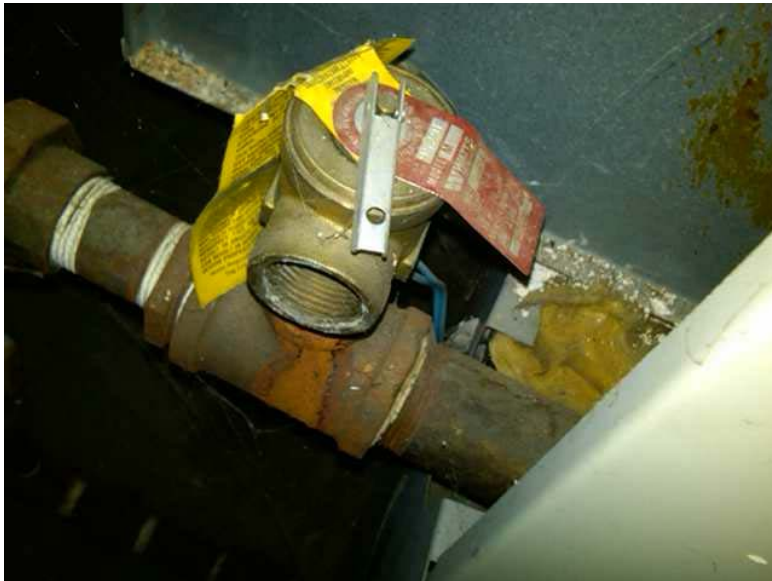
6.3 HEATING SYSTEM  
Installation & Operation

Missing discharge pipe off relief valve. Due to the age and condition of the boiler I would recommend annual boiler inspections be performed for proper function and safety prior to each heating season and budgeting for replacement.

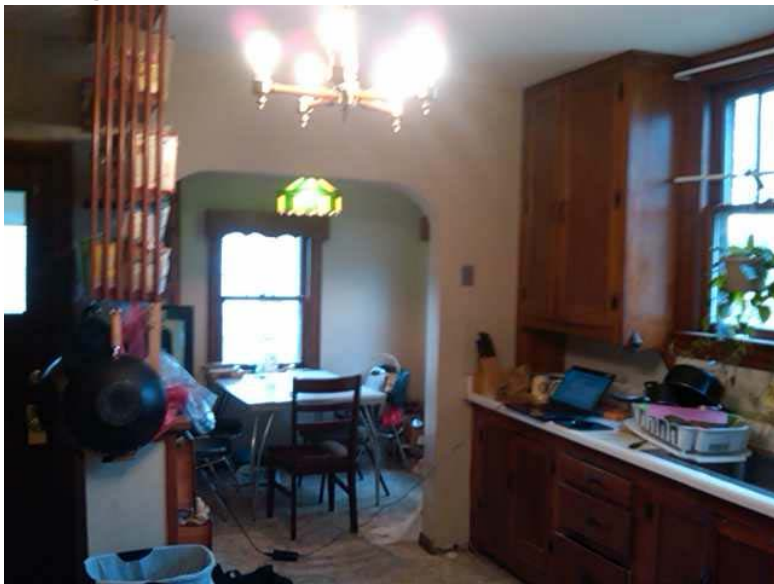
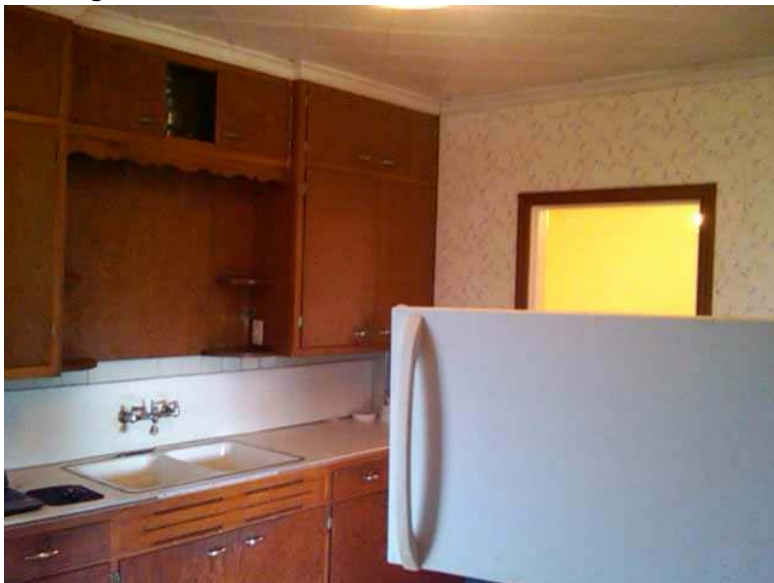
**8.2 INTERIOR - Kitchen**  
**Ceiling & Walls**

Lower Unit: Cracks in plaster walls and ceilings.  
Upper Unit: Minor wall / ceiling deficiencies noted.
