# INSPECTION REPORT

**746 Sample Avenue**

### INSPECTION REPORT

746 Sample Avenue, St. Paul, MN

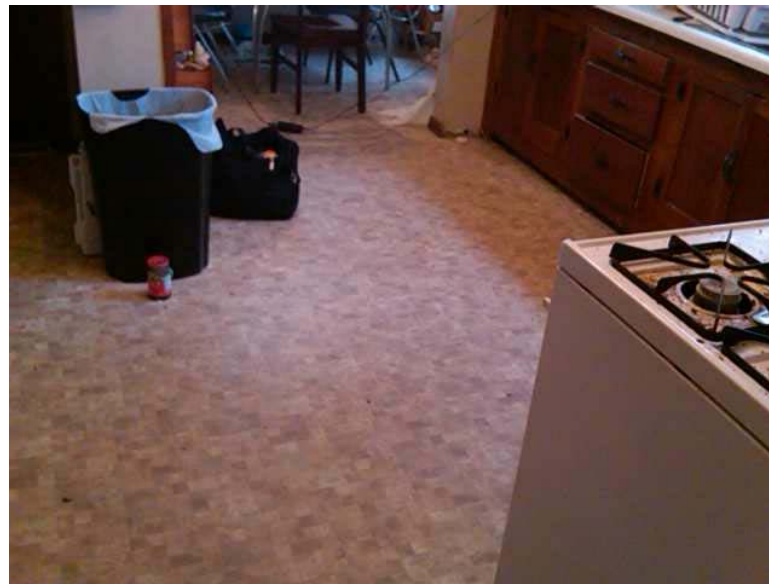
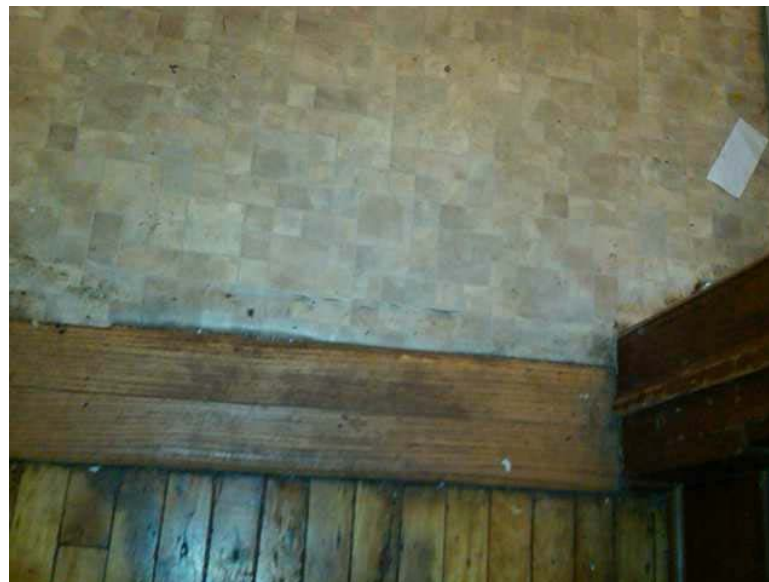
**8.3 INTERIOR - Kitchen**  
**Floors**

Lower Unit: Old flooring. Unlevel flooring. Surface wear to flooring. worn flooring at thresholds, Missing base boards.  
Upper Unit: Old flooring. Unlevel flooring. Surface wear to hardwood flooring. Old worn flooring. Gaps in flooring. Refinishing needed.

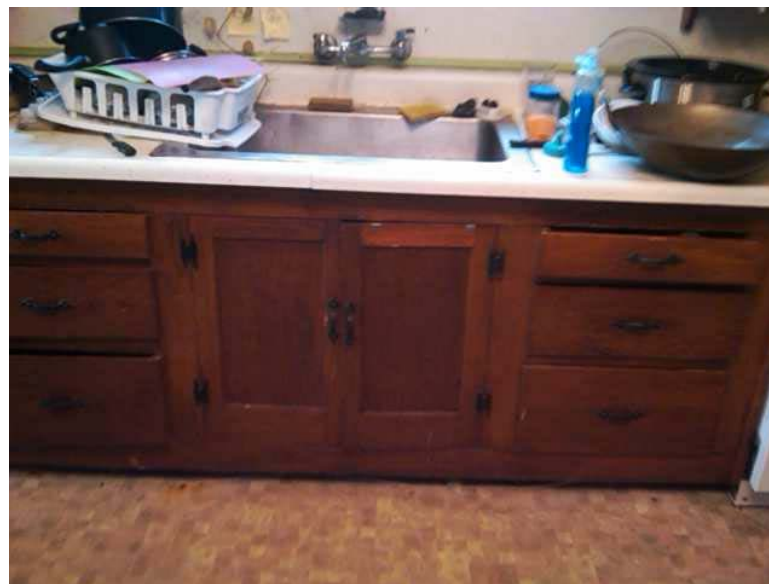
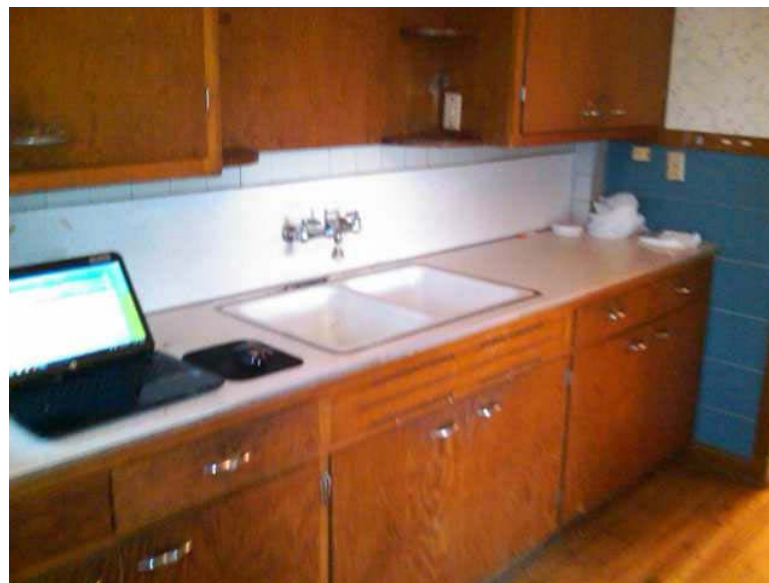
**8.6 INTERIOR - Kitchen**  
**Counter / Cabinets**

Lower Unit: Older cabinets and countertops. Unsecured countertop. Lacks proper caulk seam at backsplash. Damaged edging. Some of the cabinet doors do not close and latch properly.

Upper Unit: Damaged decayed countertop behind sink. Older cabinets and countertops. Surface wear to countertops and cabinet faces.

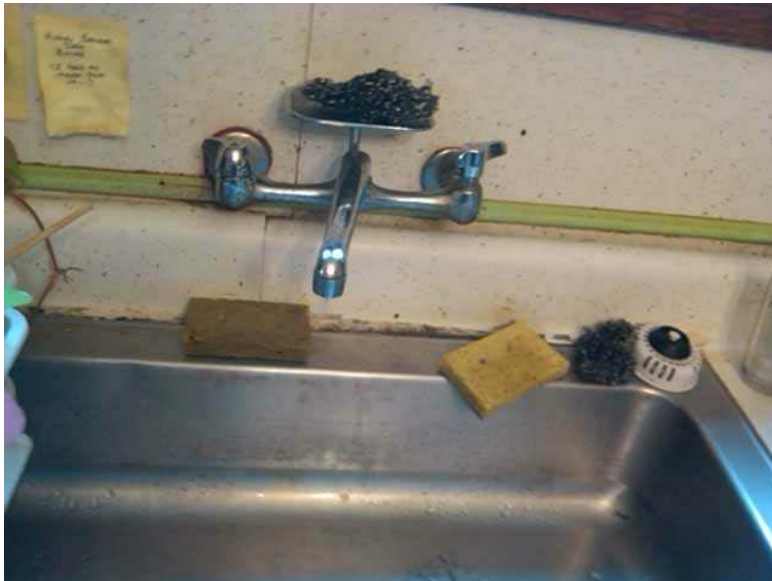
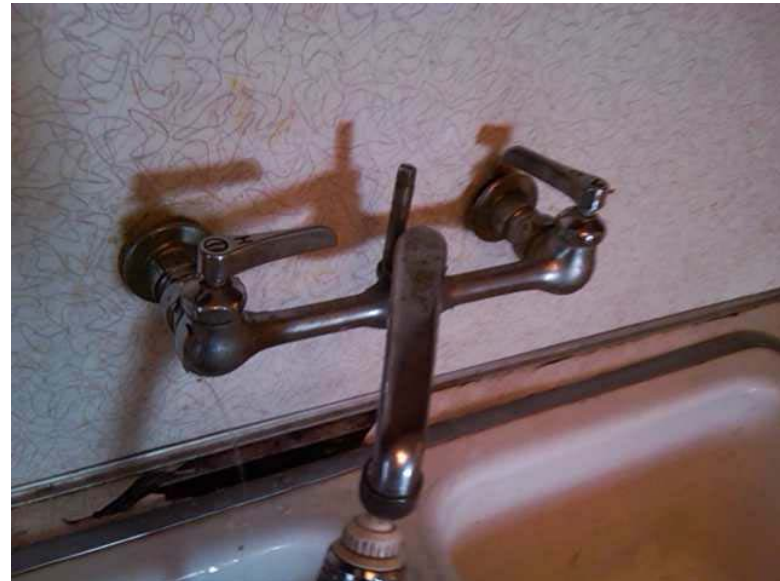
8.7 INTERIOR - Kitchen  
Sink / Basin

Lower Unit: Unvented drain pipe. Peeling paint under sink.  
Upper Unit: Active leak at the sink faucet.

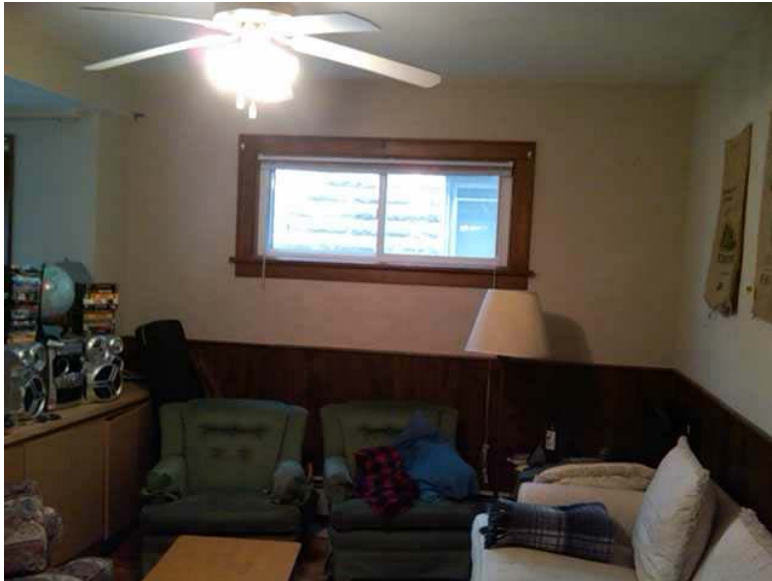
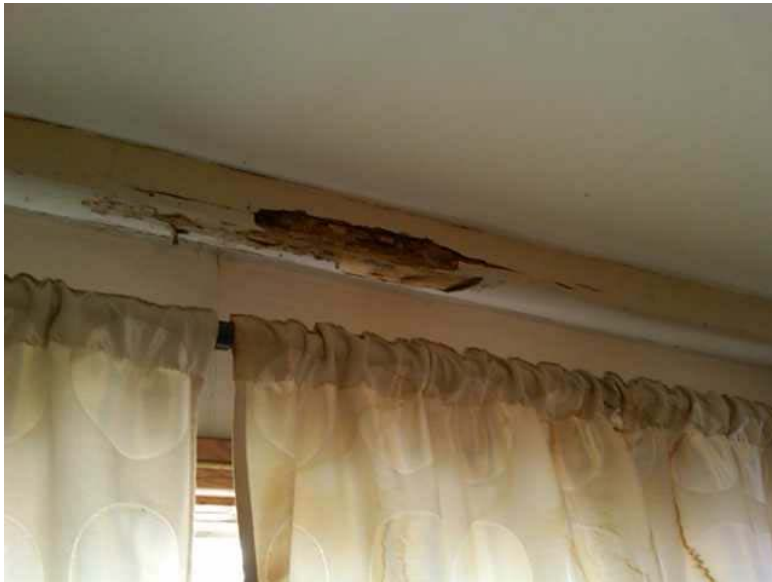
**8.10 INTERIOR - Living / Dining / Family Rooms**  
**Ceilings & Walls**

Lower Unit: Signs of leaking in ceiling at front wall (damaged plaster at ceiling).  
Upper Unit: Cracks in plaster walls/ceilings. Loose plaster, Chipped and peeling paint / stain. Patch work noted in areas.

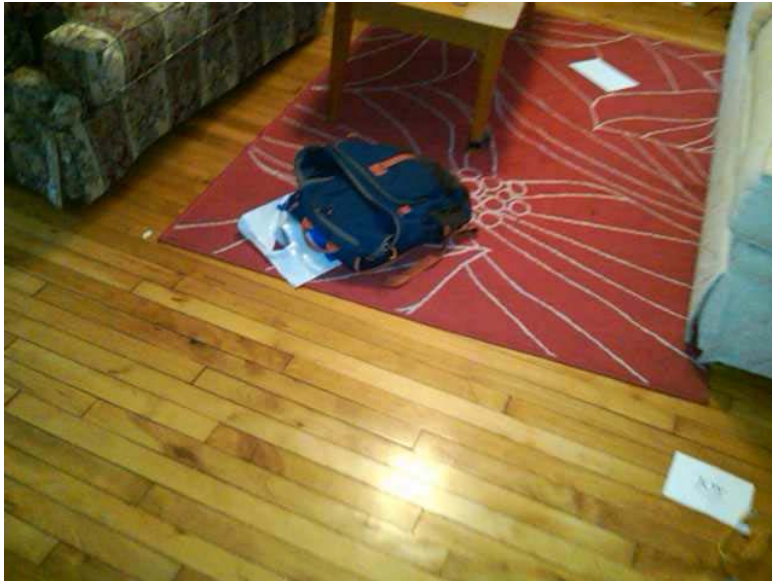
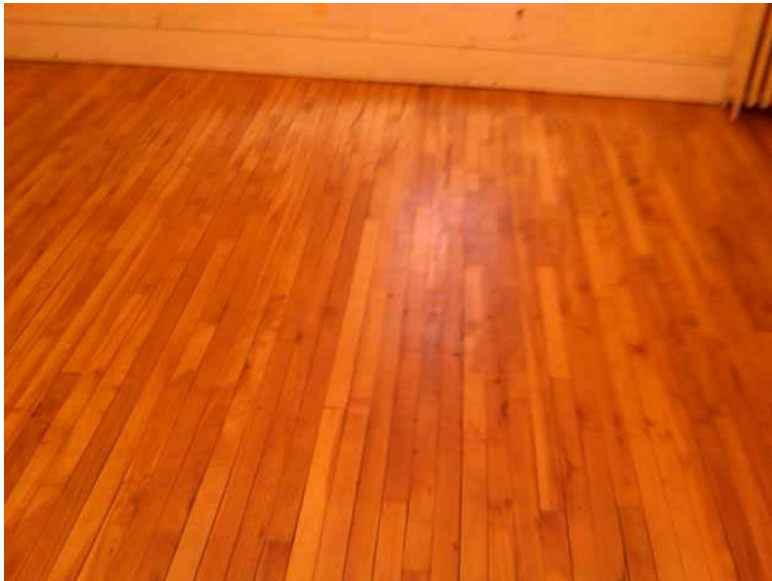
**8.11 INTERIOR - Living / Dining / Family Rooms**  
**Floors**

Lower Unit: Older flooring. Surface wear to flooring noted in traffic areas. Unlevel flooring. Gaps in flooring.  
Upper Unit: Older flooring. Surface wear to flooring noted in traffic areas. Unlevel flooring.

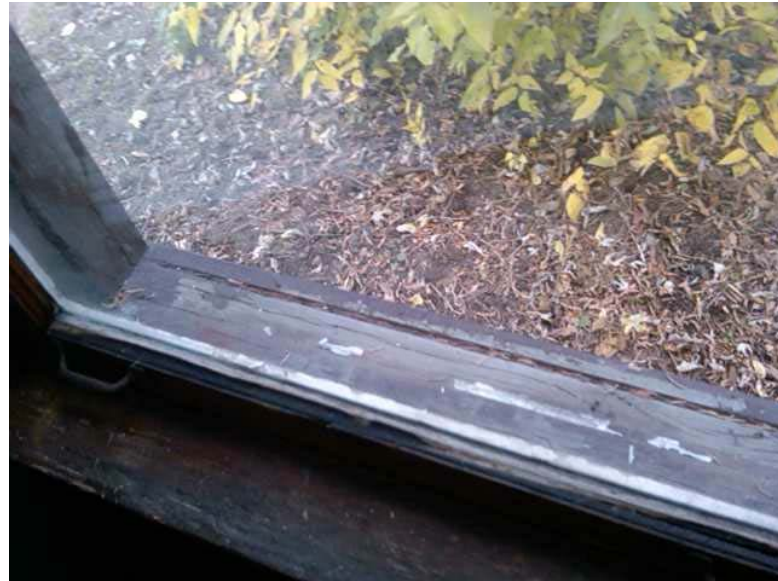
**8.13 INTERIOR - Living / Dining / Family Rooms**  
**Windows**

Lower Unit: Old wood double hung windows. Loose and missing window putty. Weathered wood components. Missing screens.

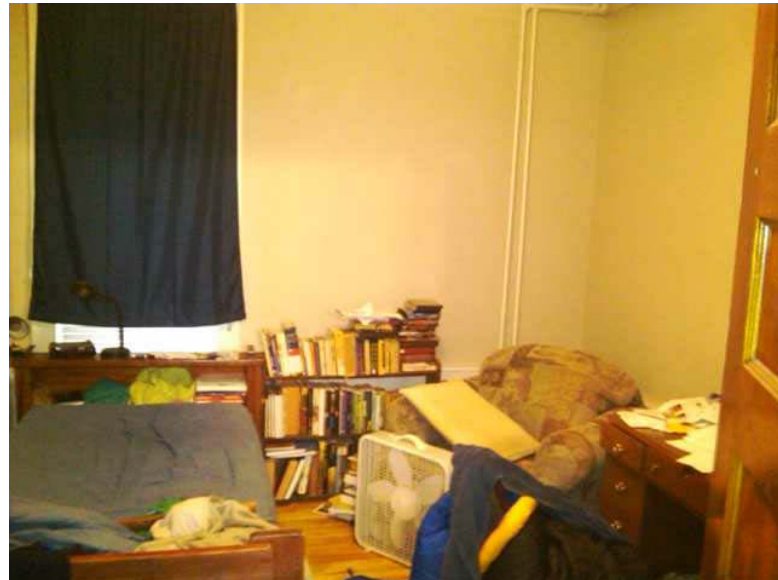
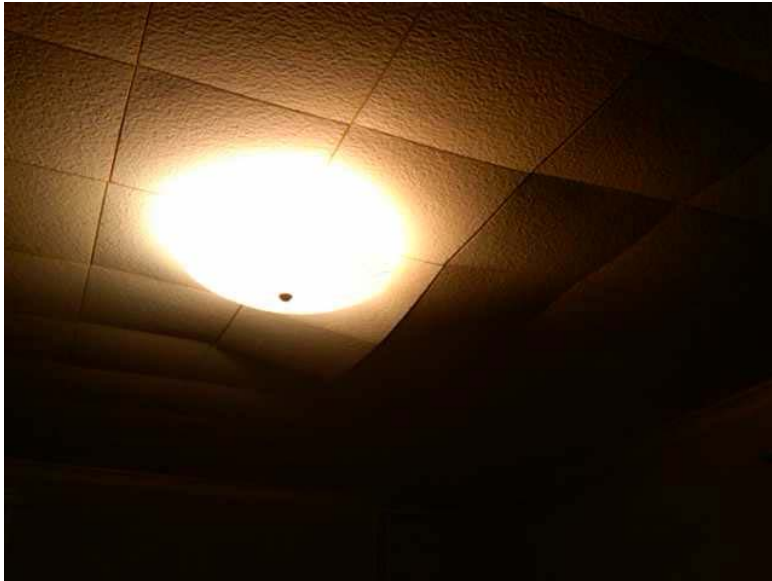
**8.15 INTERIOR - Bedroom(s)**  
**Ceilings & Walls**

Lower Unit: Minor ceiling/wall deficiencies noted. Cracks in plaster walls/ceilings.

Upper Unit: Cracks in plaster walls/ceilings. Chipped and peeling paint / stain.

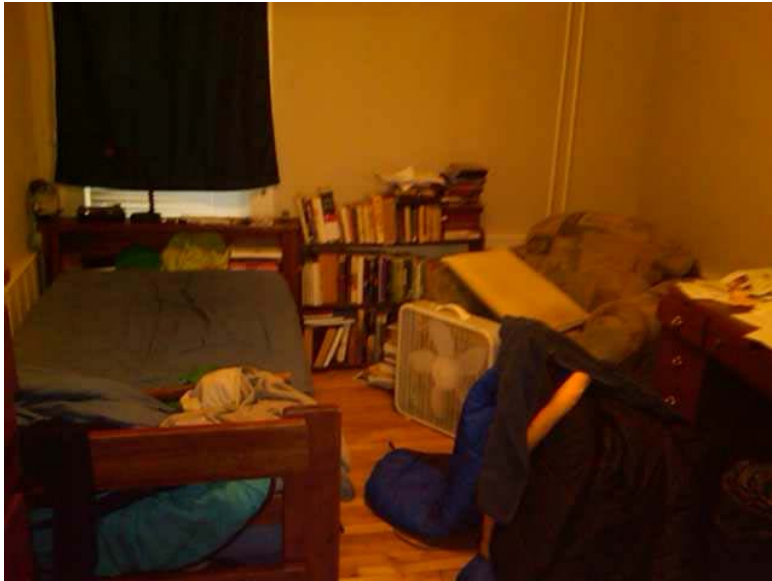
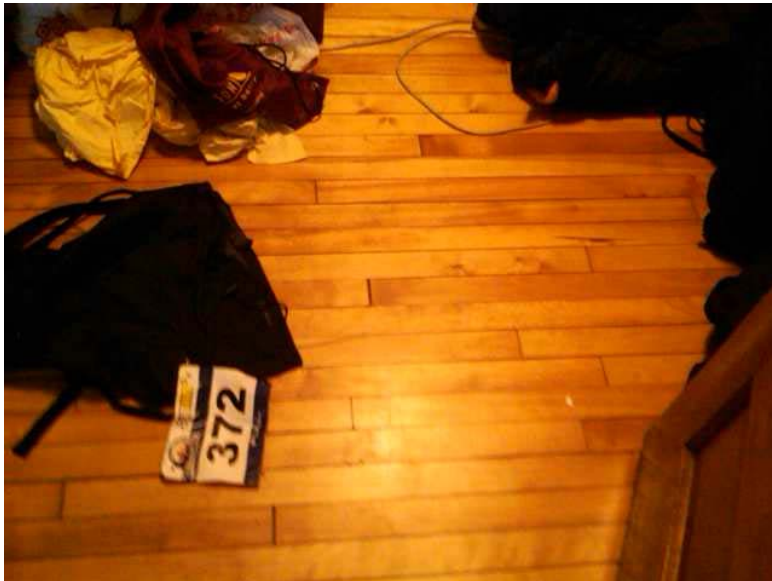
**8.16 INTERIOR - Bedroom(s)  
Floors**

Lower Unit: Older flooring. Unlevel flooring. Squeaks in flooring. Gaps in flooring.

Upper Unit: Older flooring. Unlevel flooring. Surface wear to flooring in traffic areas. Worn hardwood floors.

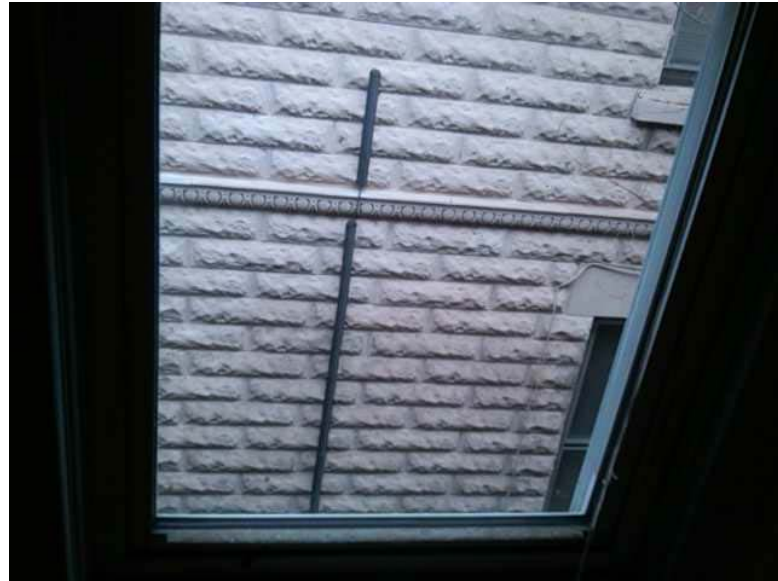
**Windows**

Lower Unit: Missing screens.

Upper Unit: Missing screens.

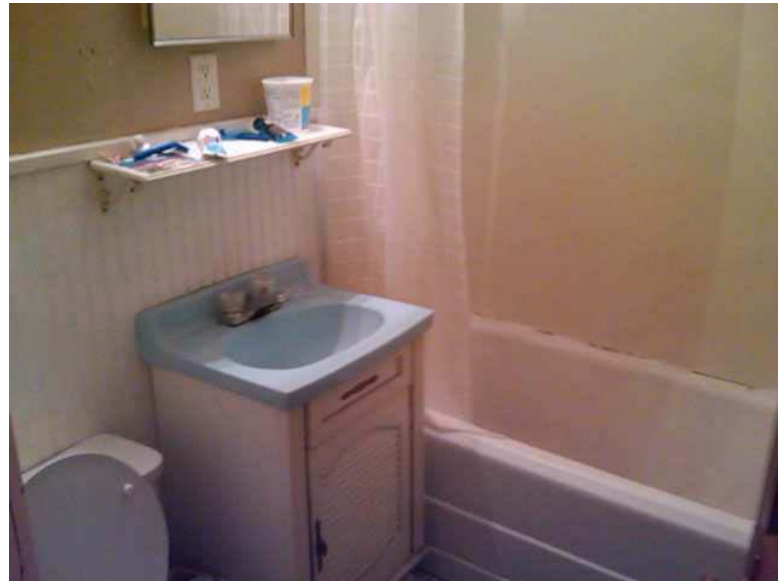
**Ceilings & Walls**

Lower Unit: Minor ceiling/wall deficiencies noted.

Upper Unit: Minor ceiling/wall deficiencies noted.

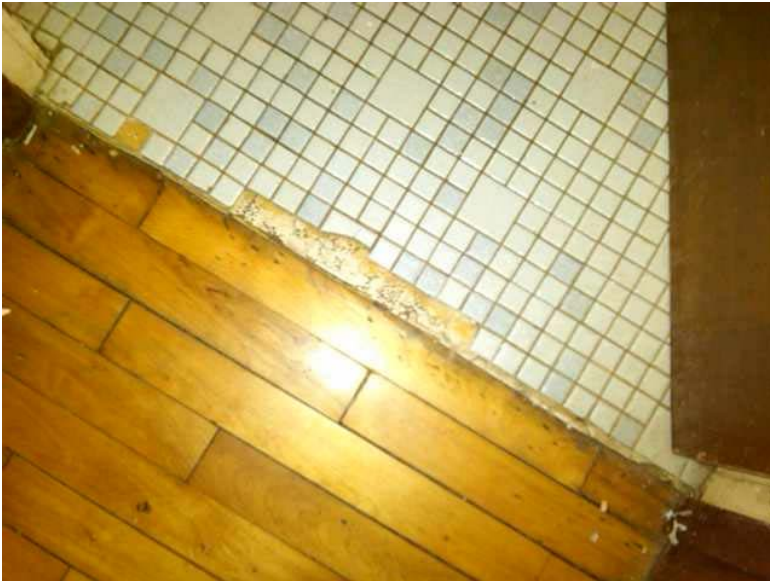
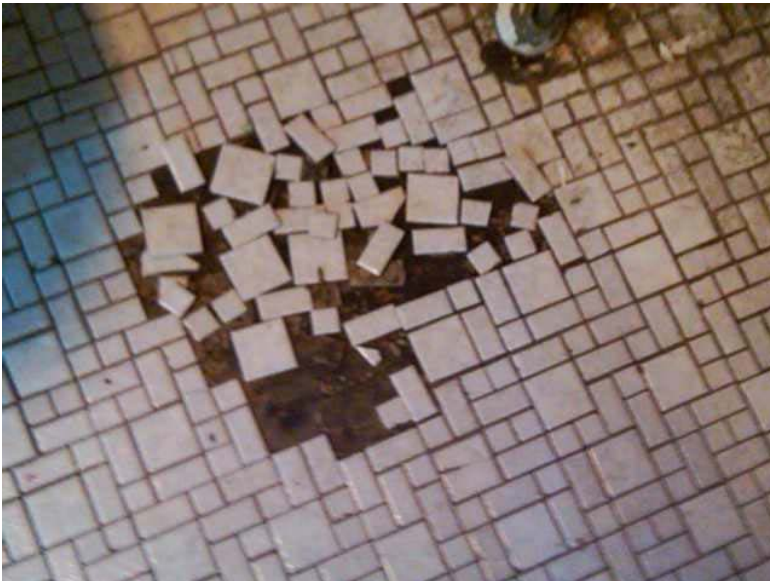
**8.21 INTERIOR - Bathroom(s)**  
**Floors**

- 8.21 Floors - Bathroom(s) Lower Unit: Damaged and missing tile, Older flooring. Unlevel. Upper Unit: Damaged/loose and missing tile, decayed subflooring.

Lower Unit: Damaged and missing tile, Older flooring. Unlevel.  
Upper Unit: Damaged/loose and missing tile, decayed subflooring.

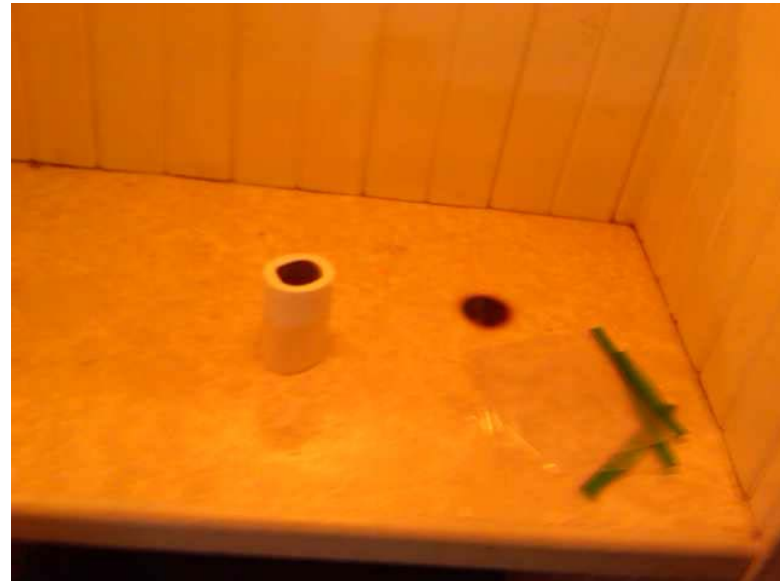
**8.24 INTERIOR - Bathroom(s)**  
**Counter / Cabinets**

Lower Unit: Older cabinets and countertops. Surface wear to cabinet faces.  
Upper Unit: Older cabinets and countertops.

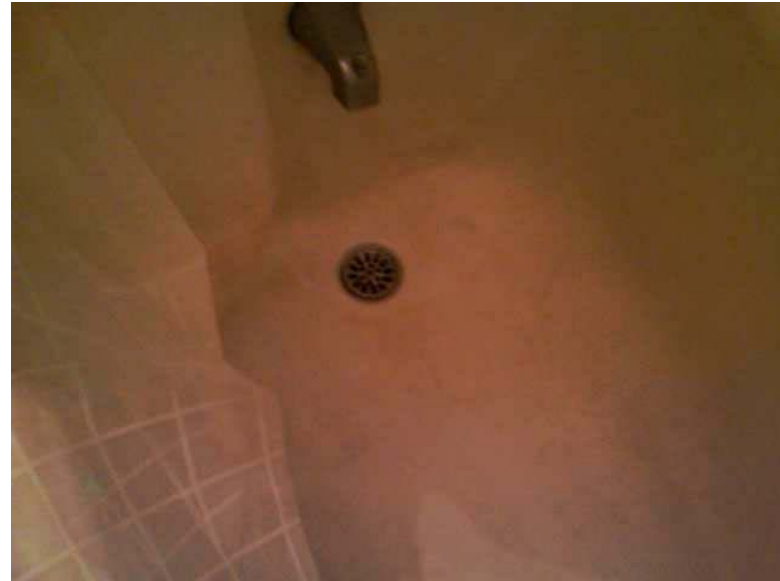
**Tub & Shower**

Lower Unit: Some deteriorated grout/caulk. Missing tub stopper.

Upper Unit: Rusted and corroded tub on exterior, leak at shower wand connection, Shower wand extends below the spill line of the tub.

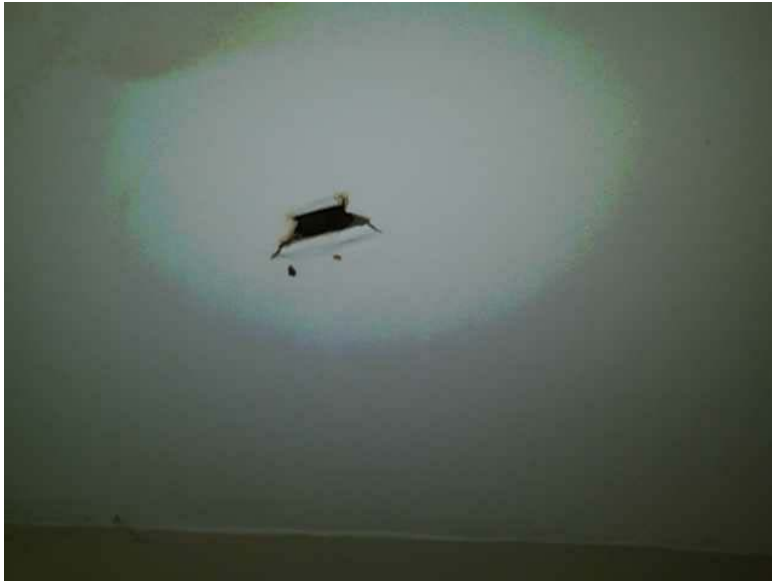
**8.31 INTERIOR - Halls / Stairways / Entries**  
**Ceilings & Walls**

Lower Unit: Hole and stains in ceiling.

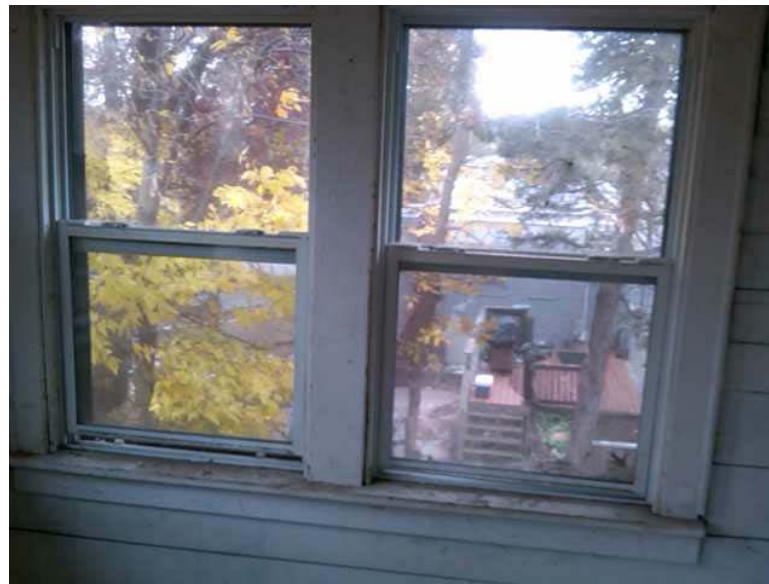
**8.34 INTERIOR - Halls / Stairways / Entries**  
**Windows**

Weathered windows. Damaged screening.

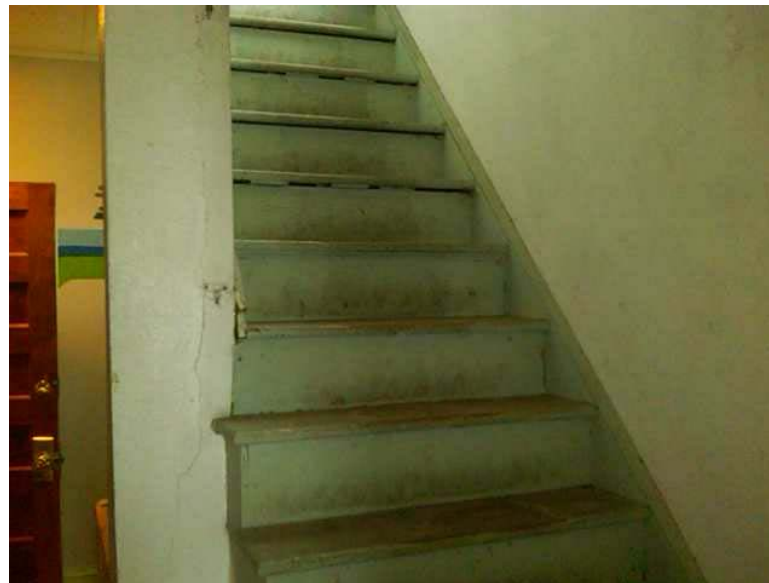
**8.35 INTERIOR - Halls / Stairways / Entries**  
**Stairs & Rails**

Upper Unit rear staircase - sloped and settled staircase/structure, Lacks handrail(s). Headroom less than 6'8" high. Improper stair rise. Improper stair run. Front staircase - Lacks handrail(s). No railing/guardrail on open side of staircase. Headroom less than 6'8" high.  
Attic staircase - Lacks handrail(s). Lacks guardrail(s). Headroom less than 6'8" high. Improper stair rise. Improper stair run.

Upper Unit rear staircase - sloped and settled staircase/structure, Lacks handrail(s). Headroom less than 6'8" high. Improper stair rise. Improper stair run. Front staircase - Lacks handrail(s). No railing/guardrail on open side of staircase. Headroom less than 6'8" high. Attic staircase - Lacks handrail(s). Lacks guardrail(s). Headroom less than 6'8"

high. Improper stair rise. Improper stair run.
