# INSPECTION REPORT

**746 Sample Avenue**

### INSPECTION REPORT

746 Sample Avenue, St. Paul, MN

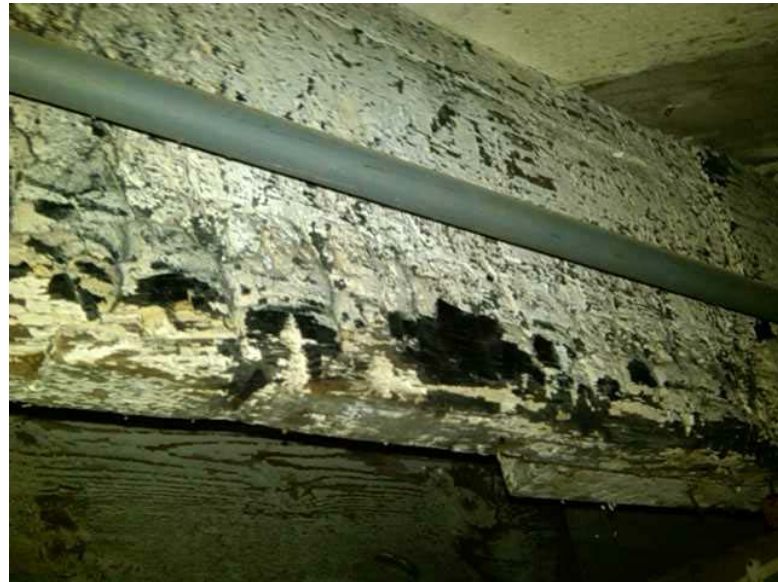
**1.10 STRUCTURAL SYSTEM**

Lacks proper support at basement windows. Evidence of a past fire near boiler (charred wood components).

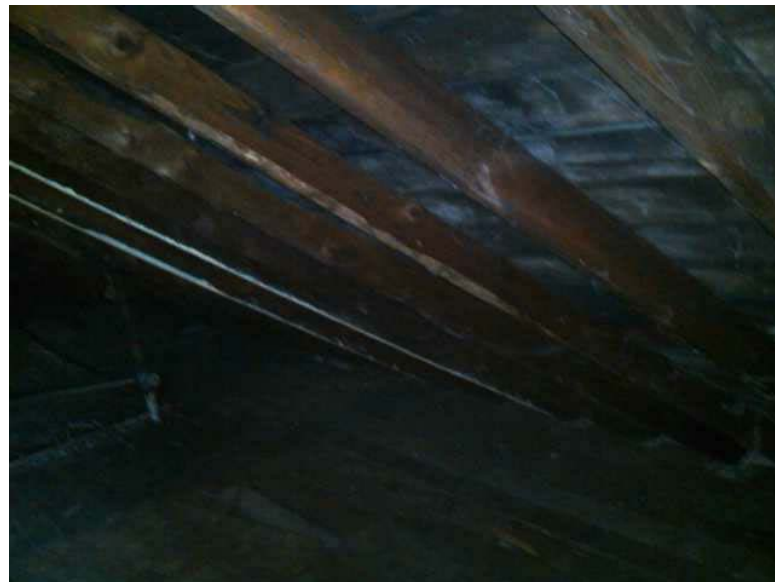
**1.14 STRUCTURAL SYSTEM**

Collar ties lacking. Lacks kneewalls - consider adding.

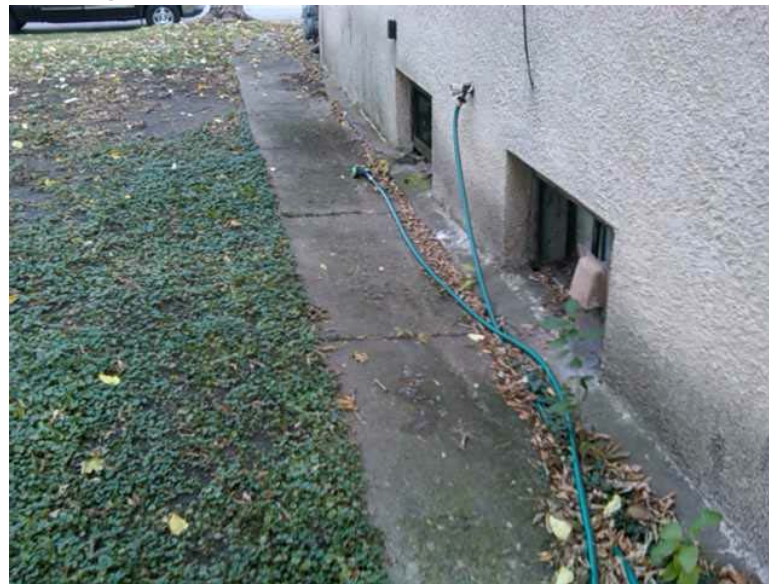
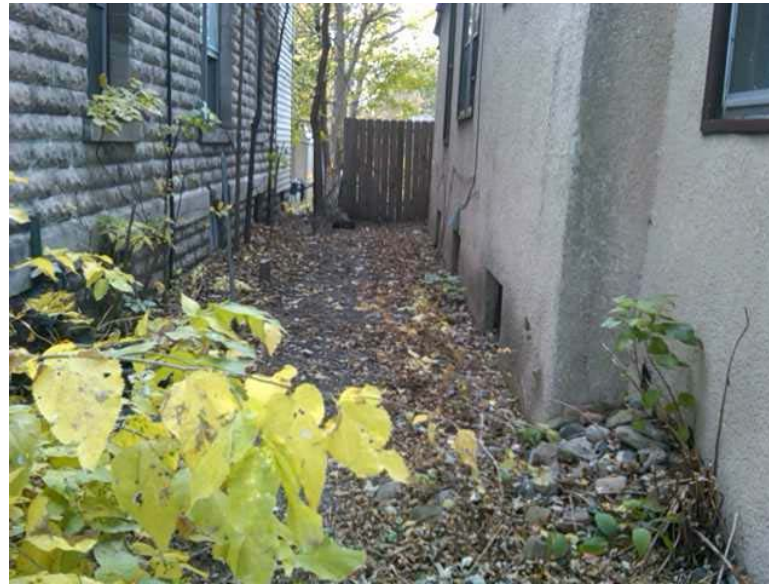
**2.1 EXTERIOR**  
**Drainage, Grade, & Slope**

- 2.1 Drainage, Grade, & Slope Flat areas close to structure. The grade in areas does not allow surface water to drain away from the foundation. Evidence of significant moisture penetration in basement - Consideration should be made to increasing the grade at all low to flat areas to help direct moisture away from the foundation.

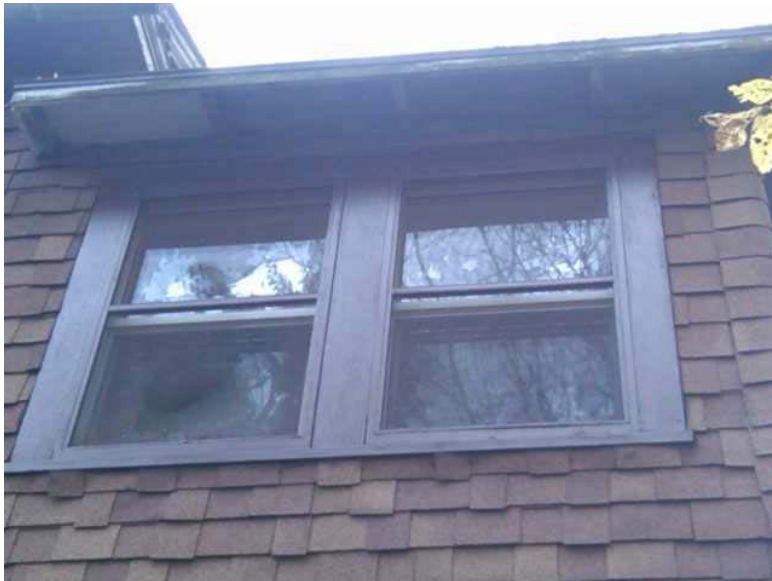
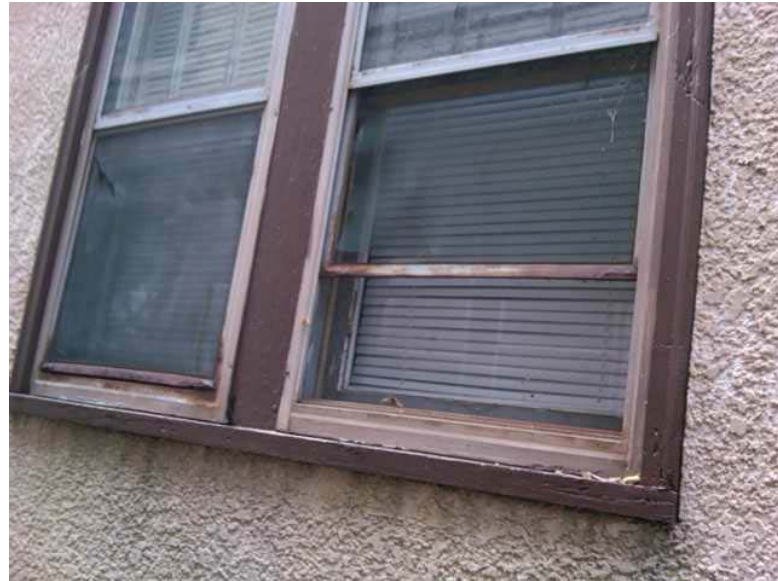
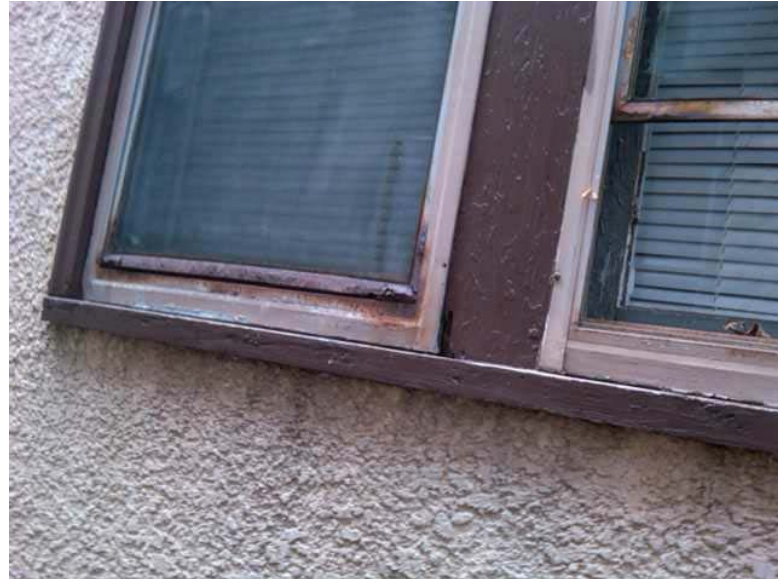
**2.11 EXTERIOR**

- 2.11 Windows Old wood double hung windows. Chipped and peeling paint. Weathered window components. Decayed trim components. Loose and missing window putty. Windows lack a protective finish. Recommend budgeting for future repairs/maintenance.

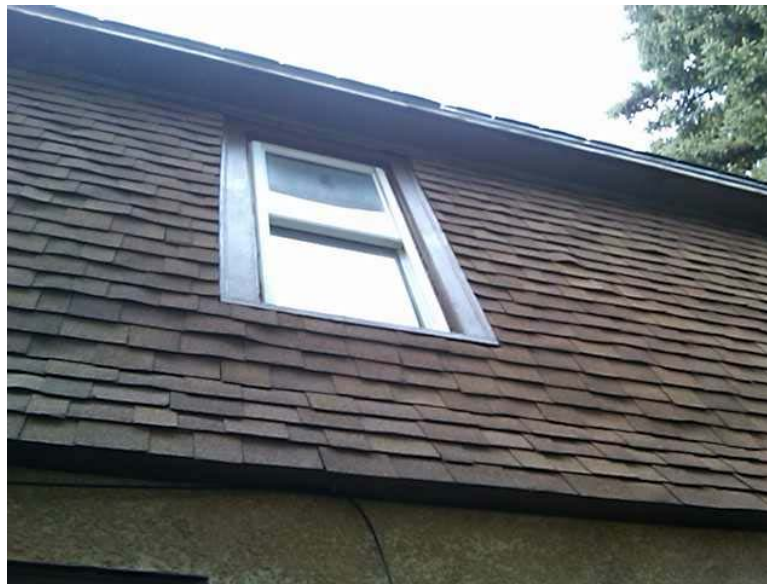
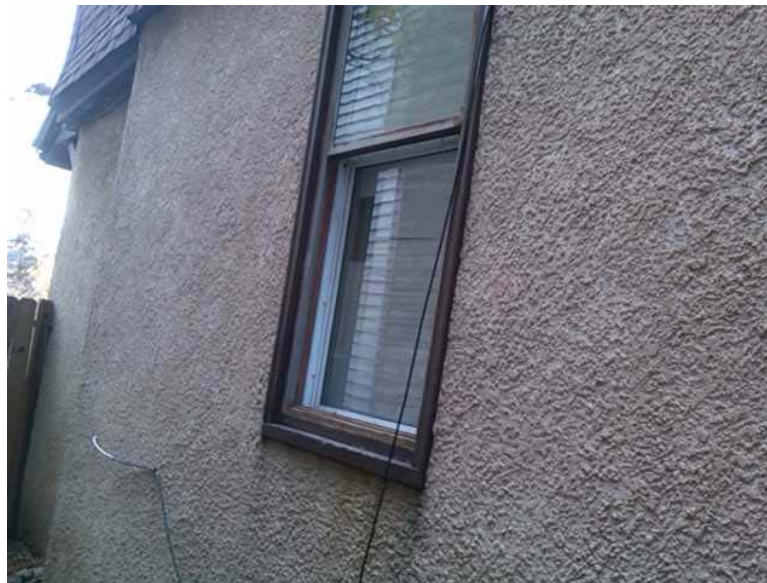
**2.12 EXTERIOR**  
**Storms & Screens**

- 2.12 Storms & Screens Rusty frames, damaged screens, missing screens, Recommend budgeting for future repairs/maintenance.

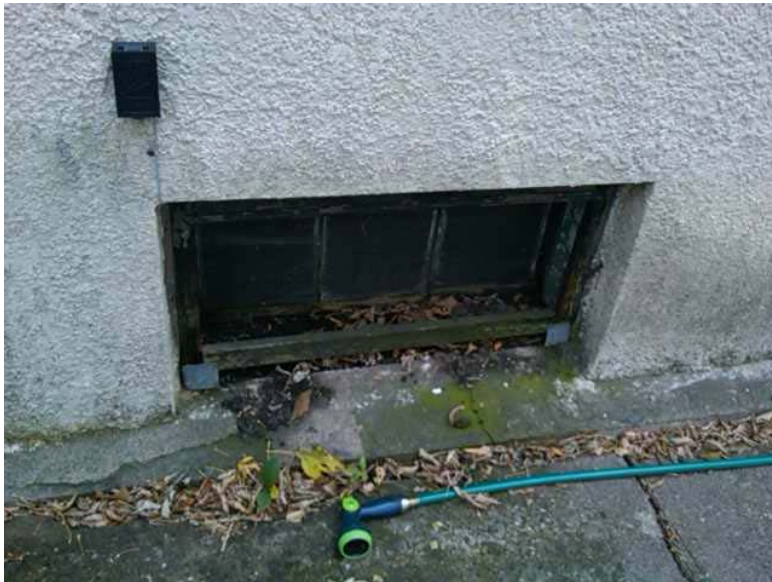
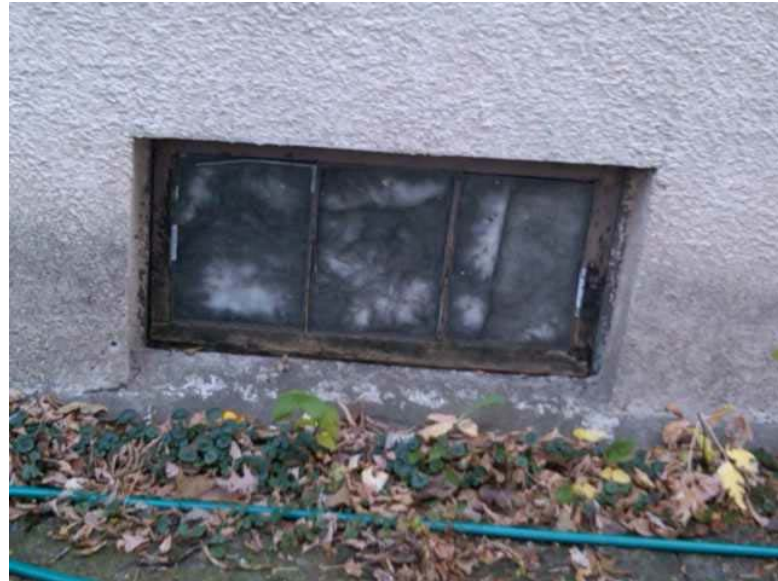
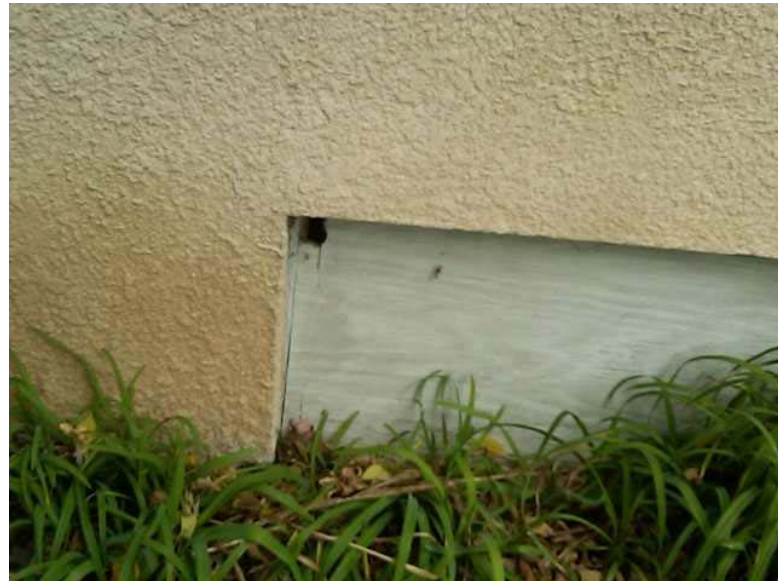
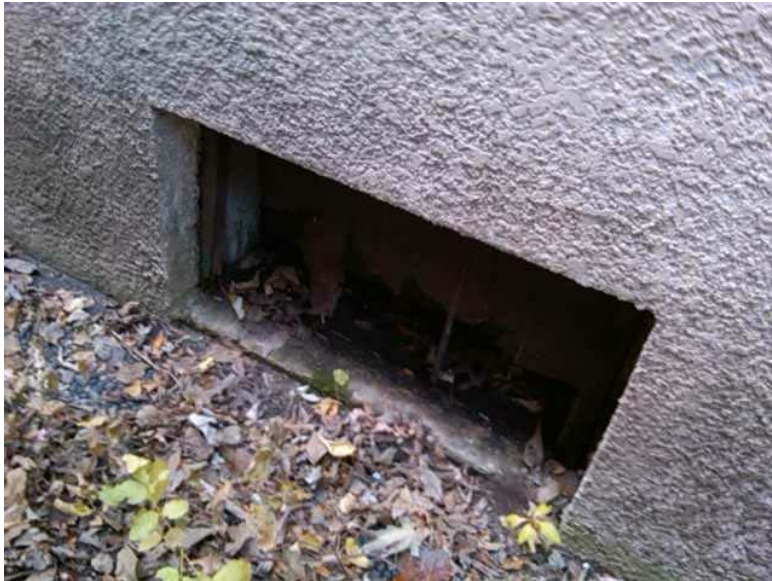
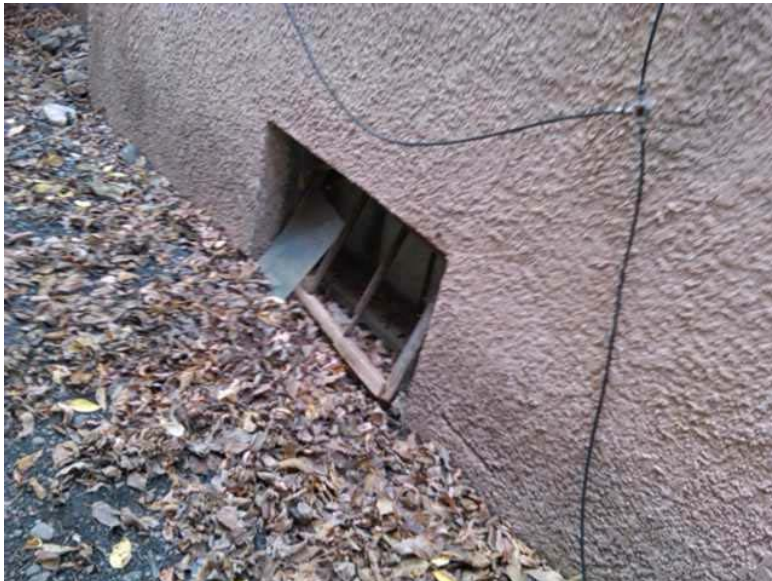
2.13 EXTERIOR

- 2.13 Basement Windows Decayed frame(s) / sill(s). Decayed and damaged components, Chipped and peeling paint. Windows lack protective finish. Some opens have been boarded over (holes).

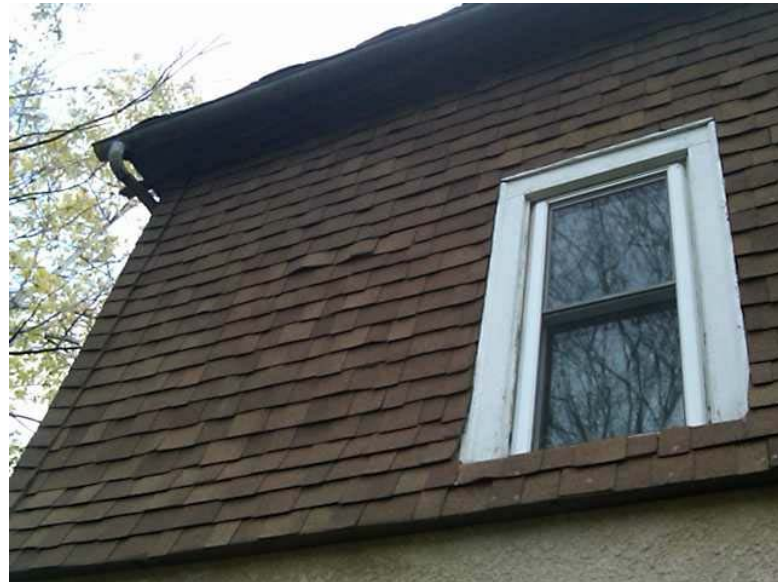
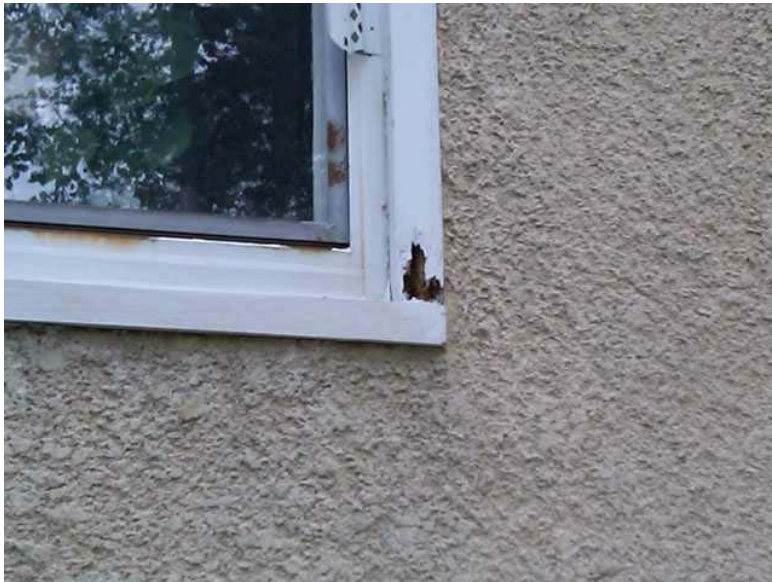
**2.15 EXTERIOR**

- 2.15 Trim Decayed trim. Holes in trim. Chipped and peeling paint. Weathered wood components. Trim lacks a protective finish in areas. Recommend budgeting for repairs/maintenance.

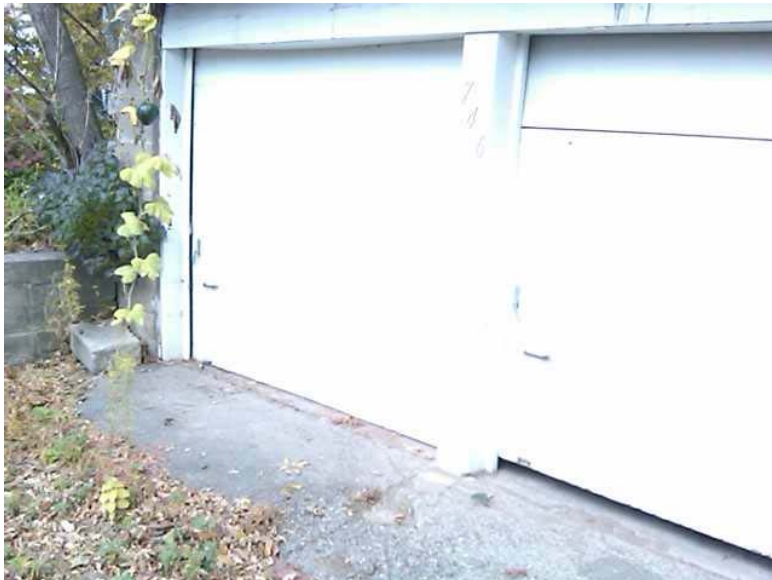
**2.19 EXTERIOR**  
**Vehicle Door(s)**

Old weather door panels. East door does not close properly.

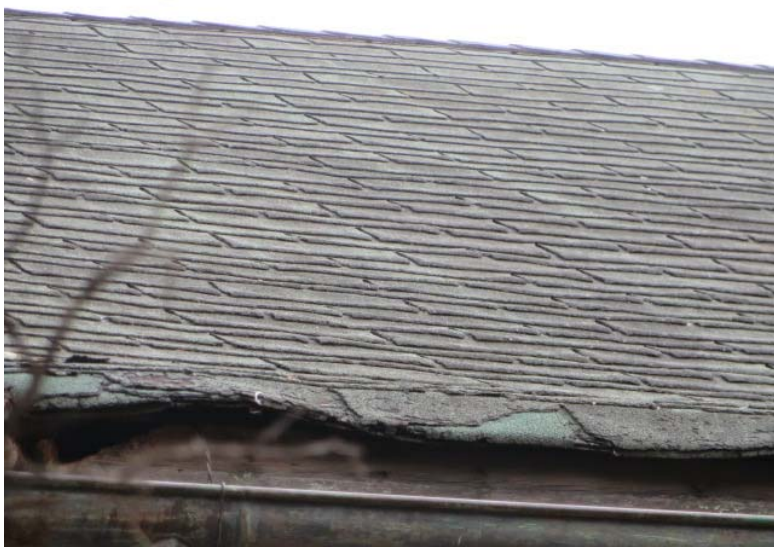
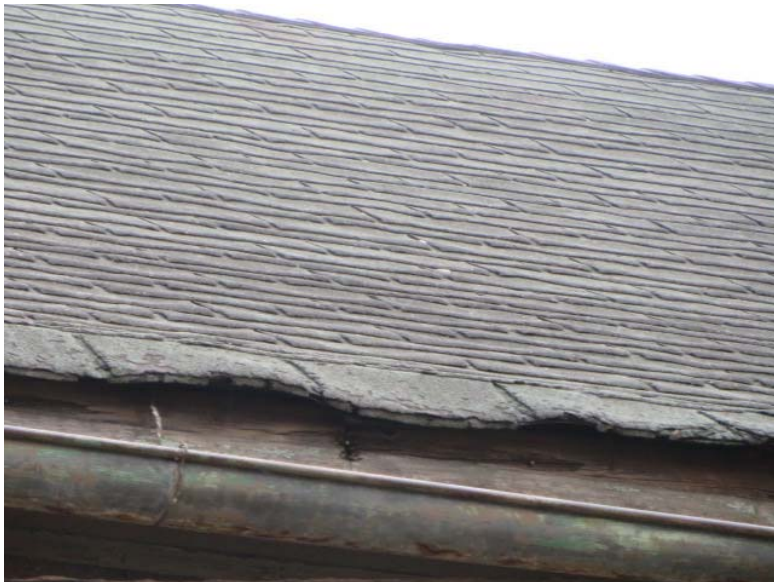
**3.3 ROOF SYSTEM**

Old asphalt shingles, Missing granules. Curled shingles. Damaged shingles at the lower edges. Shingles on the East side - significant granular loss and cured shingles. Roofing is nearing the end of its life expectancy. Recommend replacement. Recommend consulting with a Licensed Contractor.

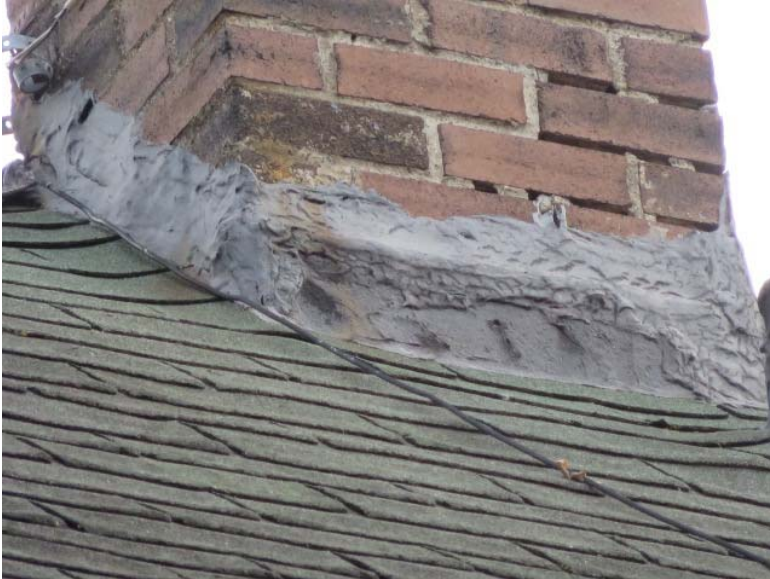
**3.5 ROOF SYSTEM**  
**Flashings & Valleys**

Tarring around penetrations. Tarring where lower roof meets upper wall (lacks proper flashing).

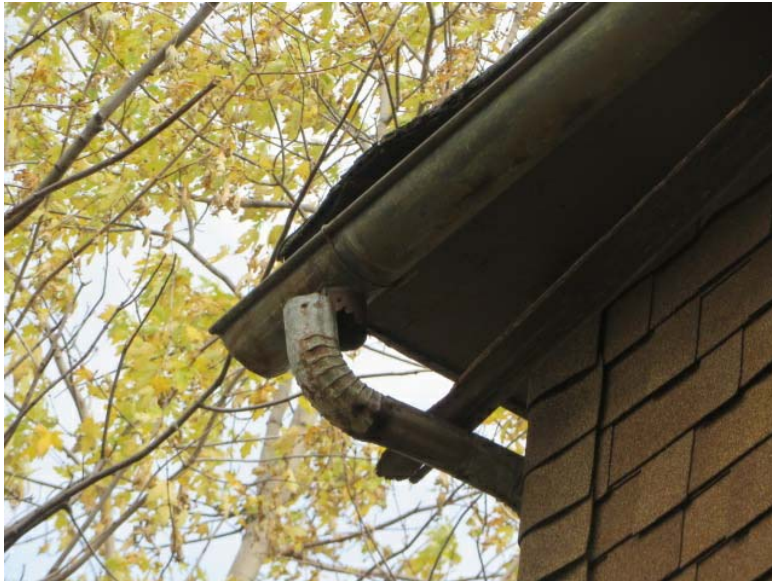
**3.8 ROOF SYSTEM**

Bent and damaged gutters, Improperly pitched gutters. Holes in gutters. Rusty gutters. Missing components.

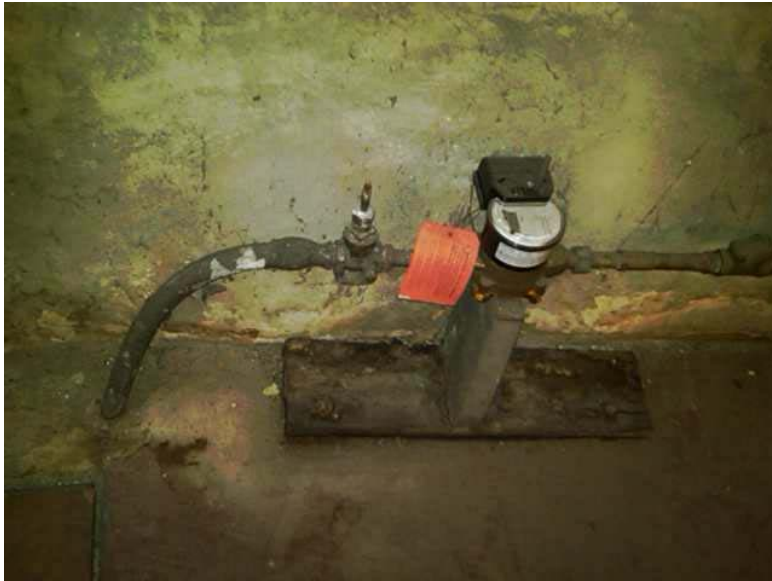
**4.1 PLUMBING SYSTEM**

Lead supply line from the street.

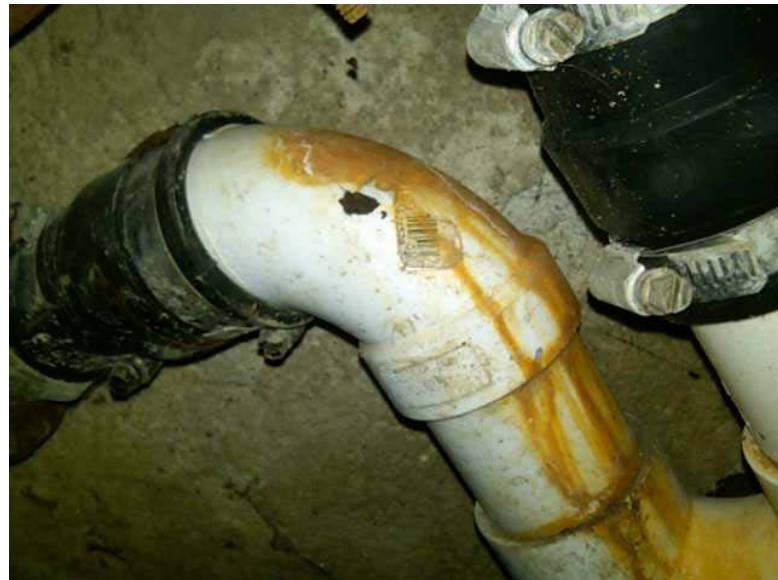
**4.6 PLUMBING SYSTEM**

Unable to view all vent and drain piping for basement fixtures due to finished surfaces. Corroded joints.  
Long trap weir at laundry tub, Improper mission coupling - (lacks a stainless steel collar) at waste assembly.

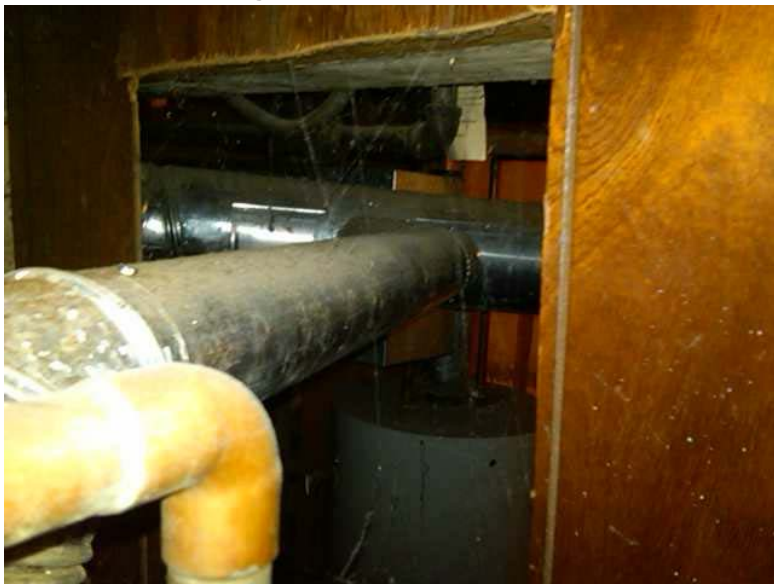
**4.17 PLUMBING SYSTEM**

Richmond - downward pitch on vent piping.

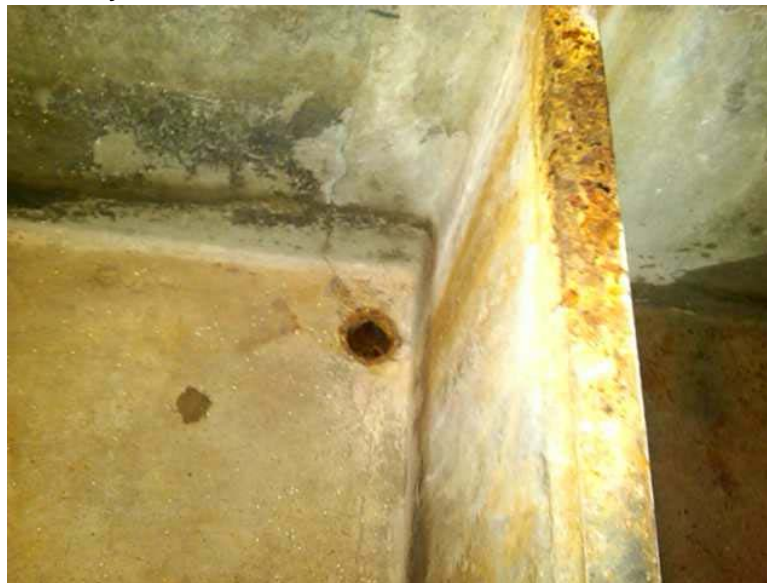
**4.19 PLUMBING SYSTEM**

Cracked cast iron laundry tub, Improper drain assembly. No backflow preventer on threaded taps.

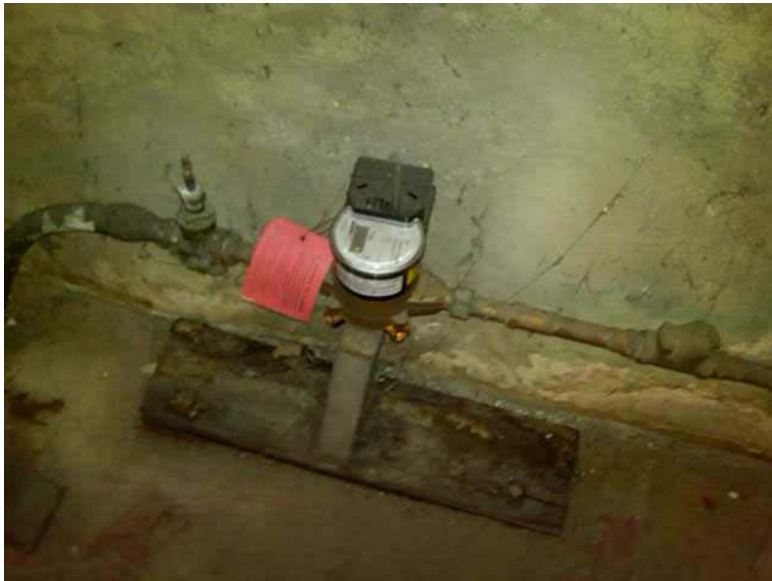
**5.3 ELECTRICAL SYSTEM**  
**System Grounding**

Lacks ground strap around water meter.

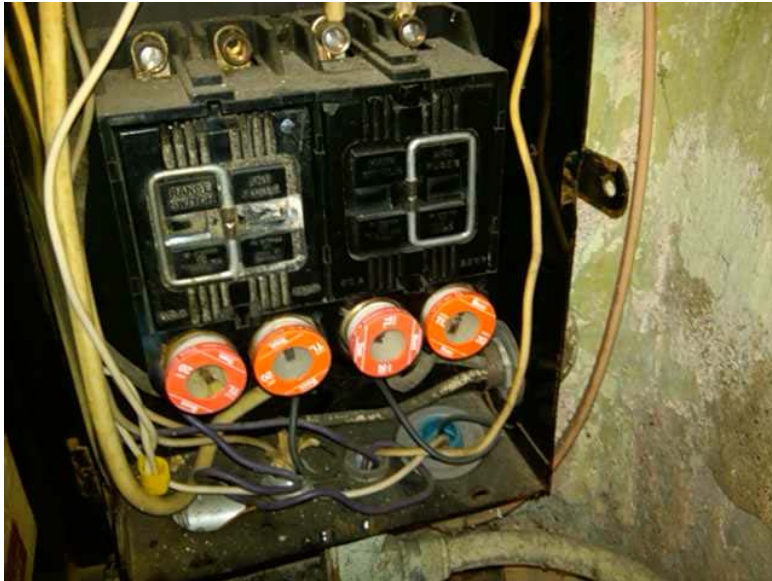
**5.4 ELECTRICAL SYSTEM**

Some circuits not indexed - recommend checking all indexing.

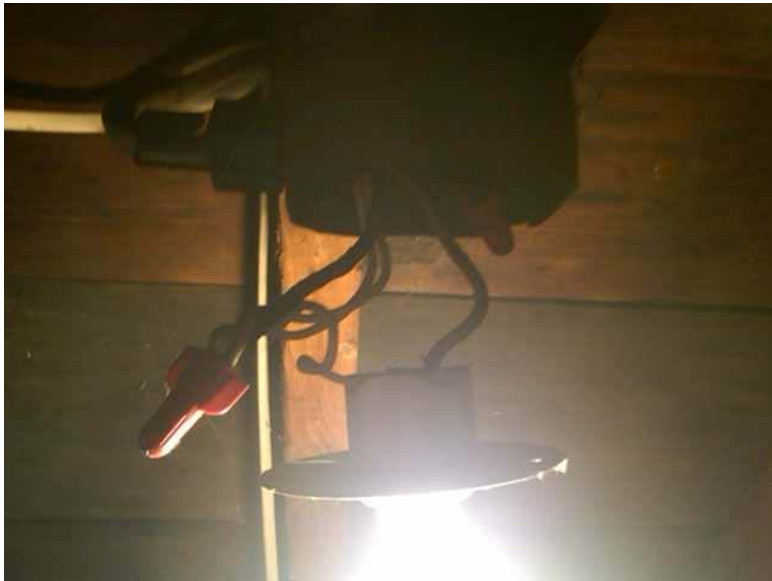
**5.8 ELECTRICAL SYSTEM**

Attic - light hanging by wires.

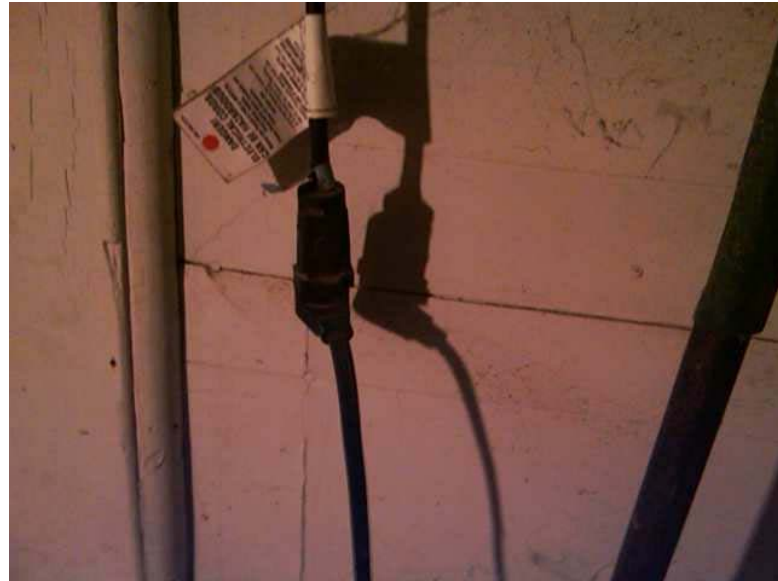
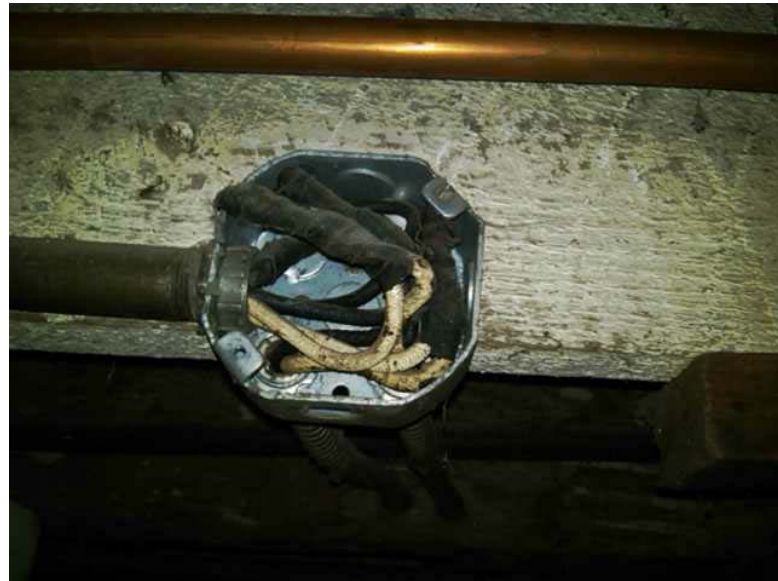
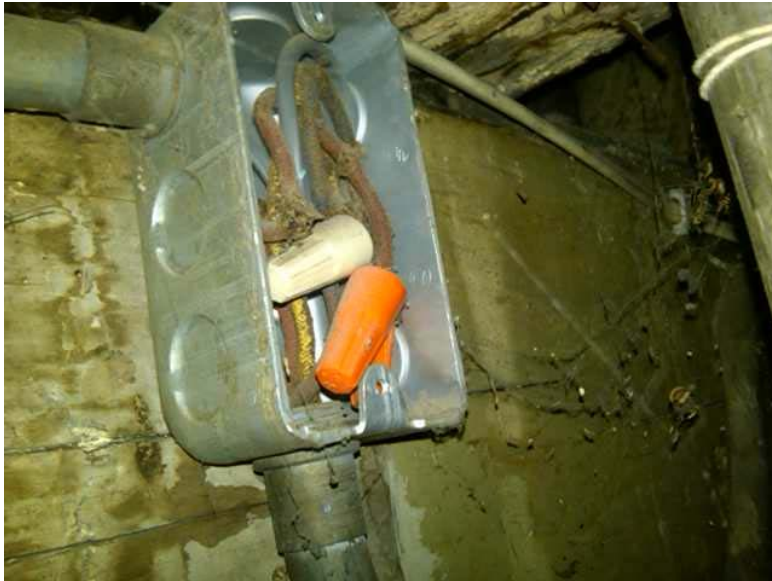
**5.9 ELECTRICAL SYSTEM**

Open junction box(es). Wiring not drilled through joists (run under joists).  
Extension cords run in lieu of permanent wiring.

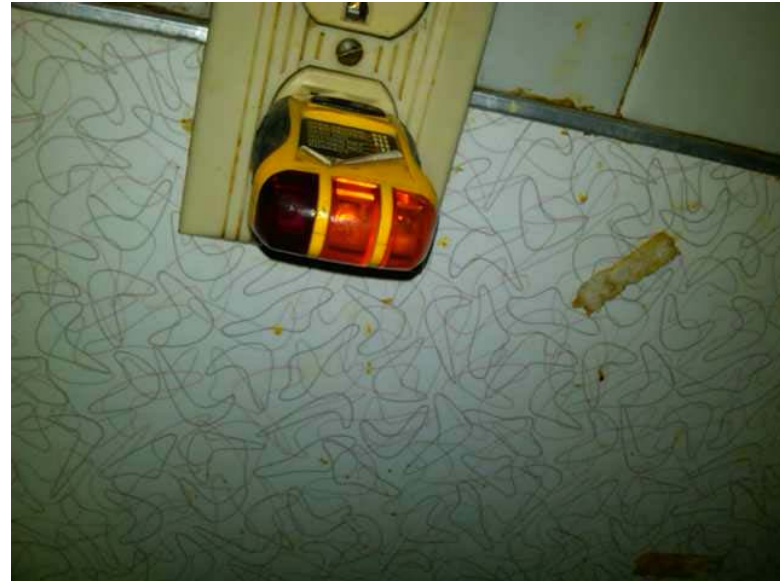
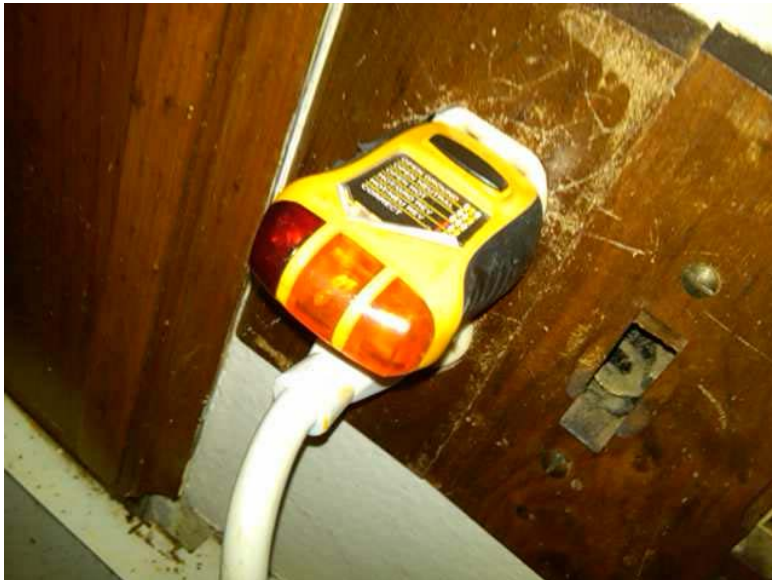
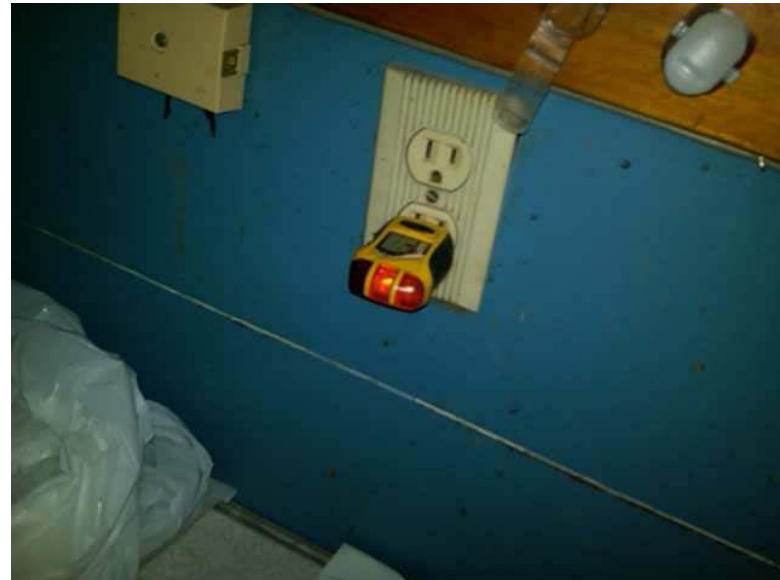
5.13 ELECTRICAL SYSTEM - Kitchen  
Electrical

Lower Unit: Reversed polarity at outlet, No GFCI outlets.  
Upper Unit: Ungrounded 3 prong outlet(s). No GFCI outlets.

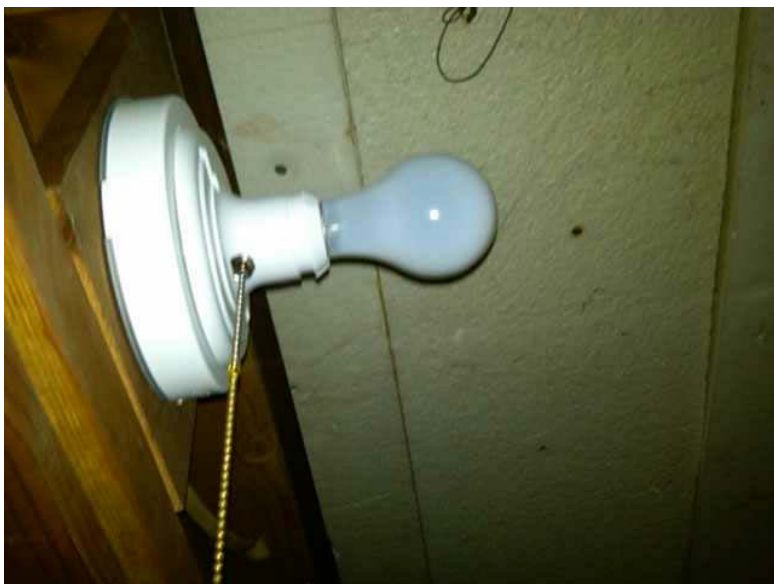
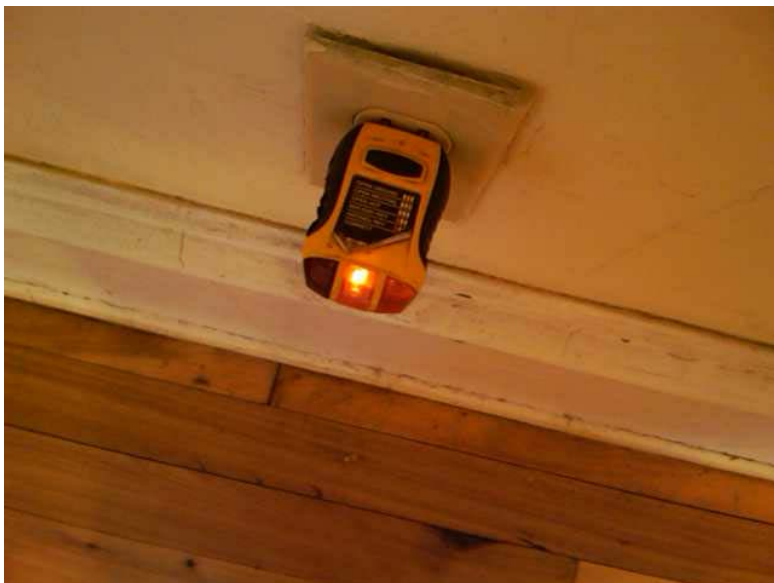
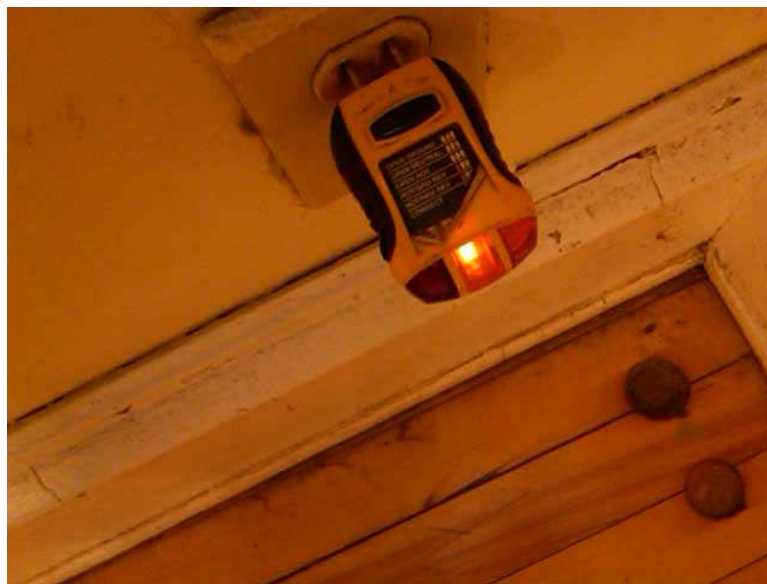
**5.14 ELECTRICAL SYSTEM - Living / Dining / Family Rooms**  
**Electrical**

Lower Unit: Closet light lacks a protective globe.  
Upper Unit: Ungrounded 3 prong outlet(s).

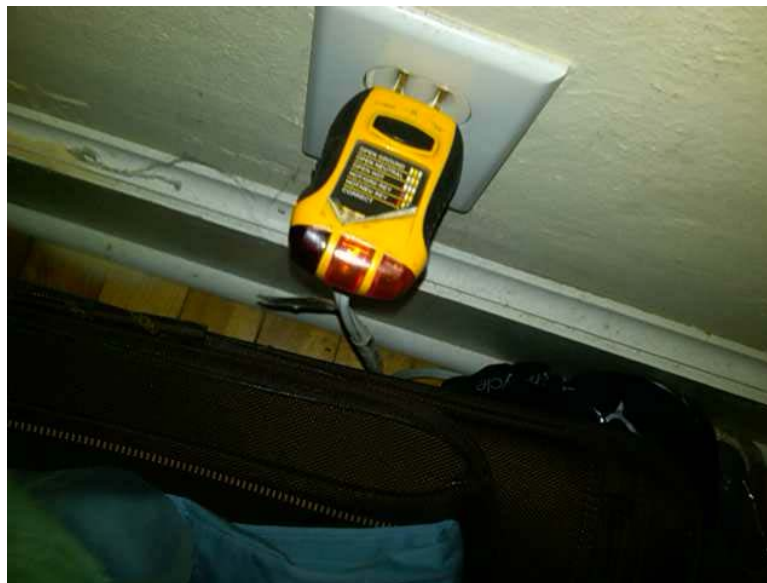
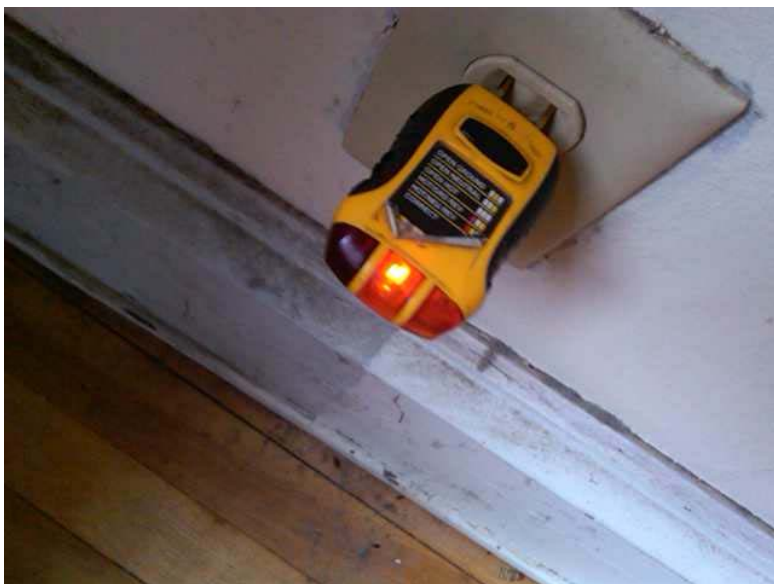
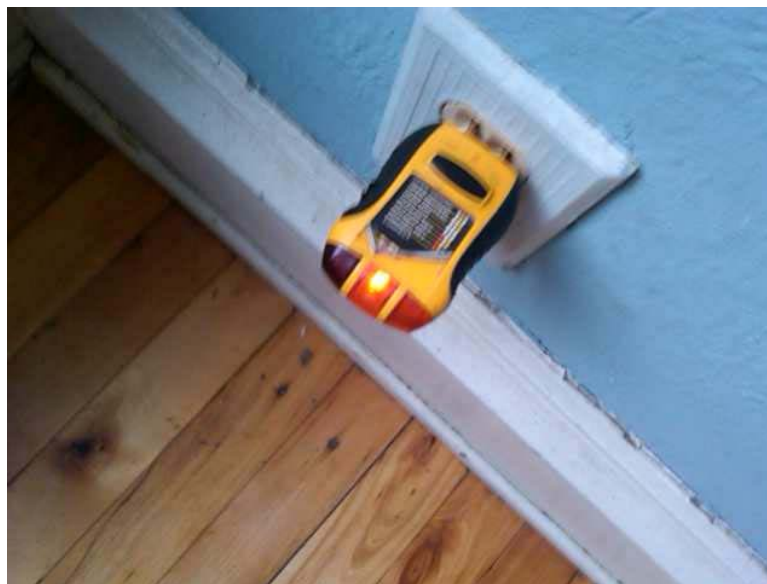
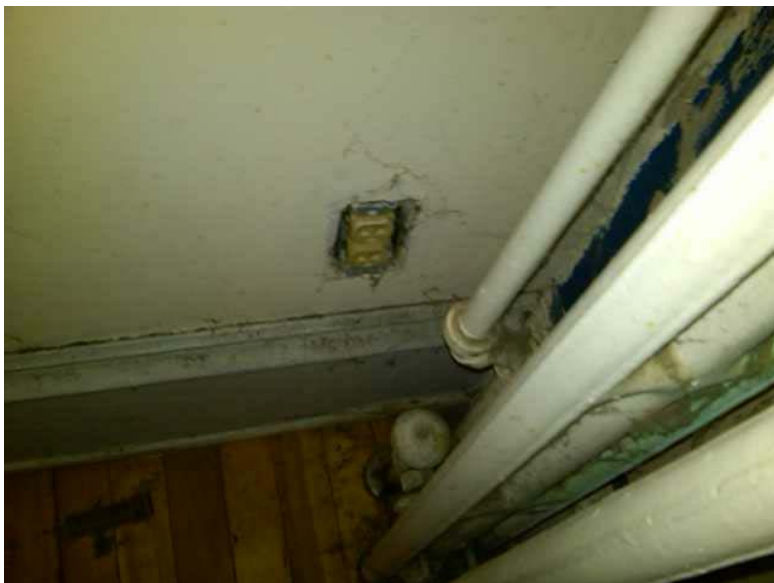
**5.15 ELECTRICAL SYSTEM - Bedroom(s)**  
**Electrical**

Lower Unit: Ungrounded 3 prong outlet(s).  
Upper Unit: Ungrounded 3 prong outlet(s). Missing fixture components. Missing cover plate(s).

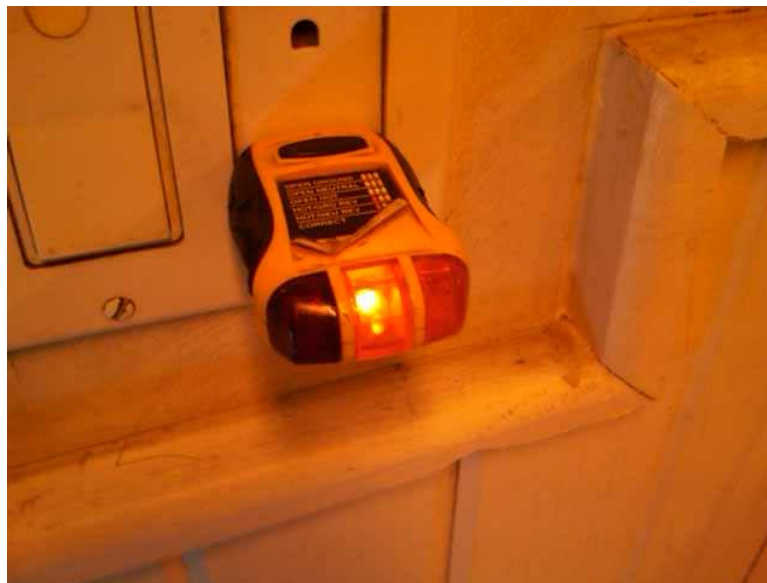
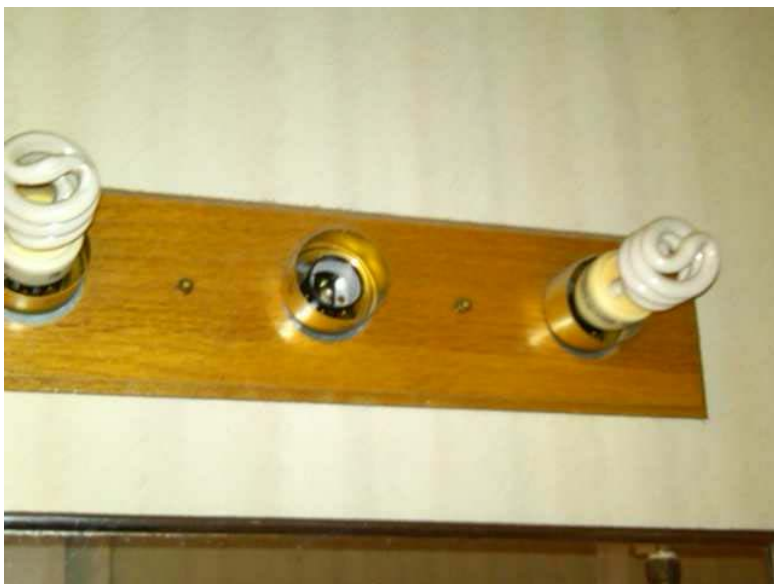
5.16 ELECTRICAL SYSTEM - Bathroom(s)

Upper Unit: Ungrounded 3 prong outlet(s). No GFCI outlets.

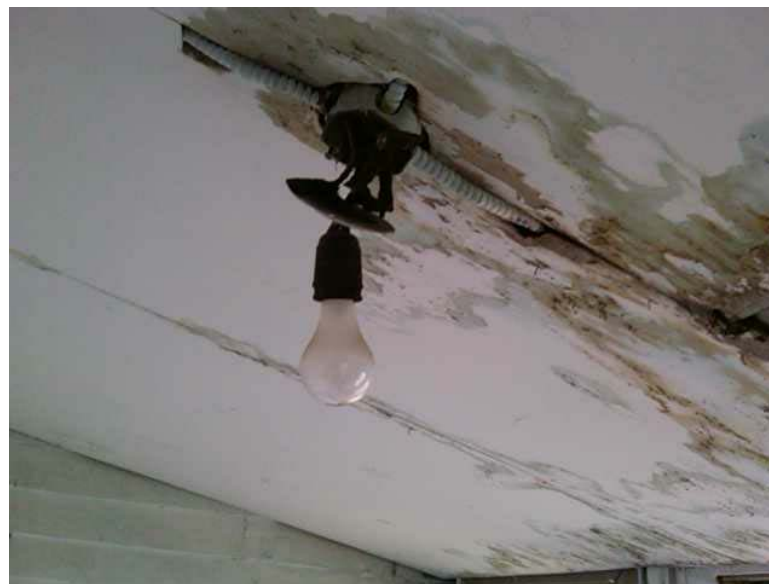
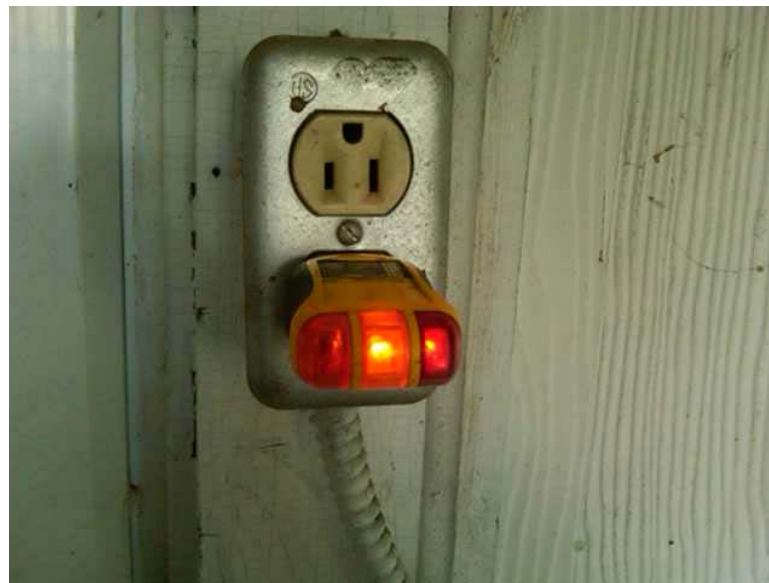
**5.17 ELECTRICAL SYSTEM - Halls / Stairways / Entries**

Lower Unit: Missing hardwired smoke alarm.

Upper Unit: Rear staircase - lights hanging by wires, Ungrounded 3 prong outlet(s). Missing smoke alarm, Lacks Carbon Monoxide Detectors one at least 10 feet from bedrooms.

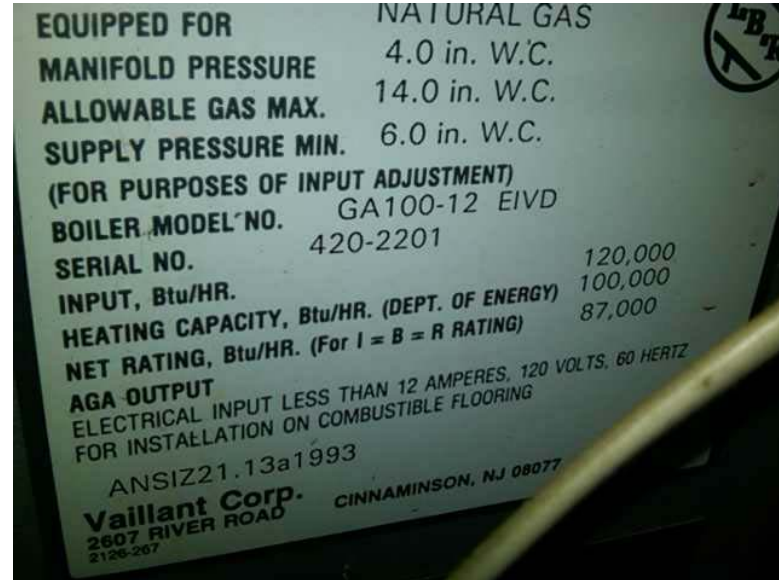
6.5 HEATING SYSTEM  
Central Heating Age

15+ years.

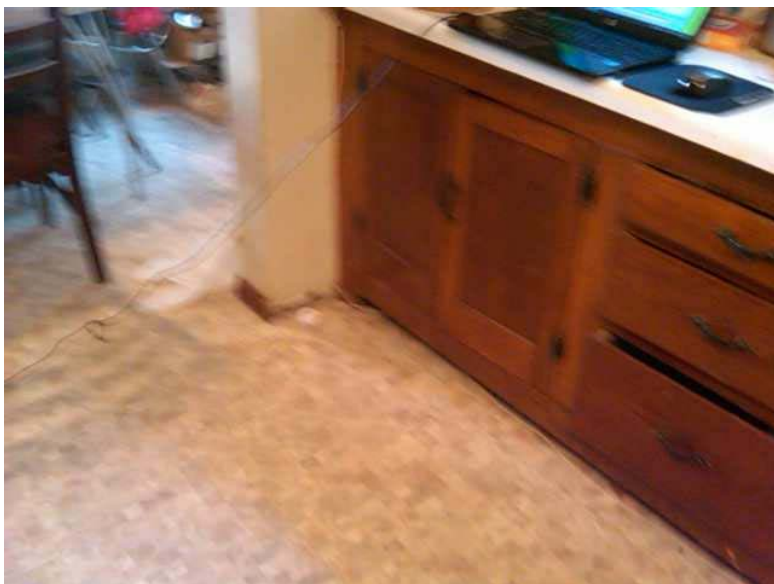
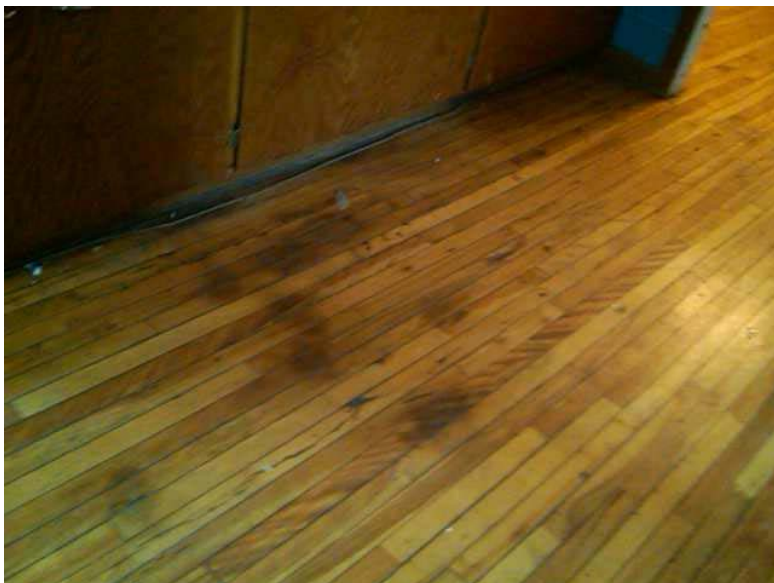
**8.3 INTERIOR**  
**Floors**

Lower Unit: Old flooring. Unlevel flooring. Surface wear to flooring. worn flooring at thresholds, Missing base boards.  
Upper Unit: Old flooring. Unlevel flooring. Surface wear to hardwood flooring. Old worn flooring. Gaps in flooring. Refinishing needed.

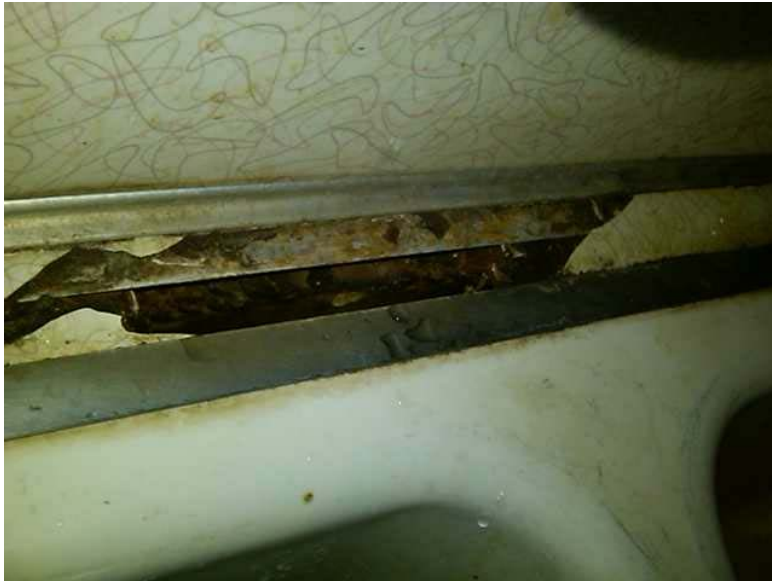
8.6 INTERIOR  
Counter / Cabinets

Lower Unit: Older cabinets and countertops. Unsecured countertop. Lacks proper caulk seam at backsplash. Damaged edging. Some of the cabinet doors do not close and latch properly.

Upper Unit: Damaged decayed countertop behind sink. Older cabinets and countertops. Surface wear to countertops and cabinet faces.
