# INSPECTION REPORT

**746 Sample Avenue**

### INSPECTION REPORT

746 Sample Avenue, St. Paul, MN

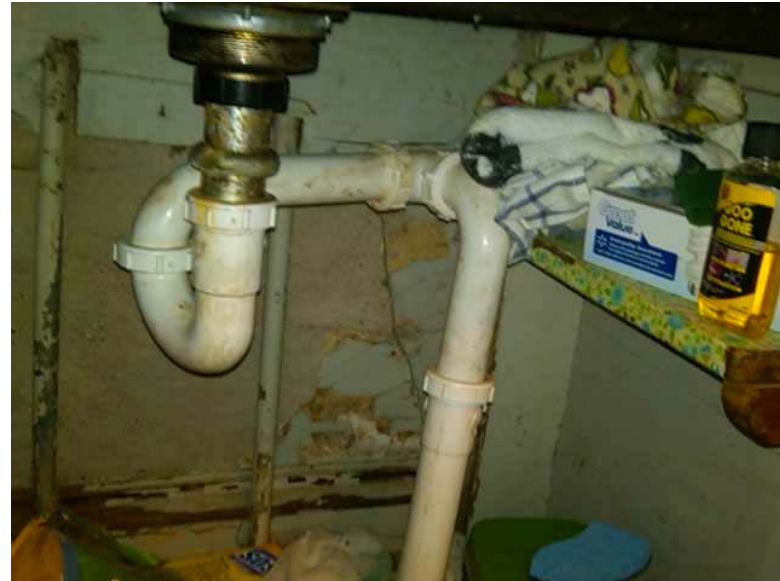
8.7 INTERIOR - Kitchen  
Sink / Basin

Lower Unit: Unvented drain pipe. Peeling paint under sink.  
Upper Unit: Active leak at the sink faucet.

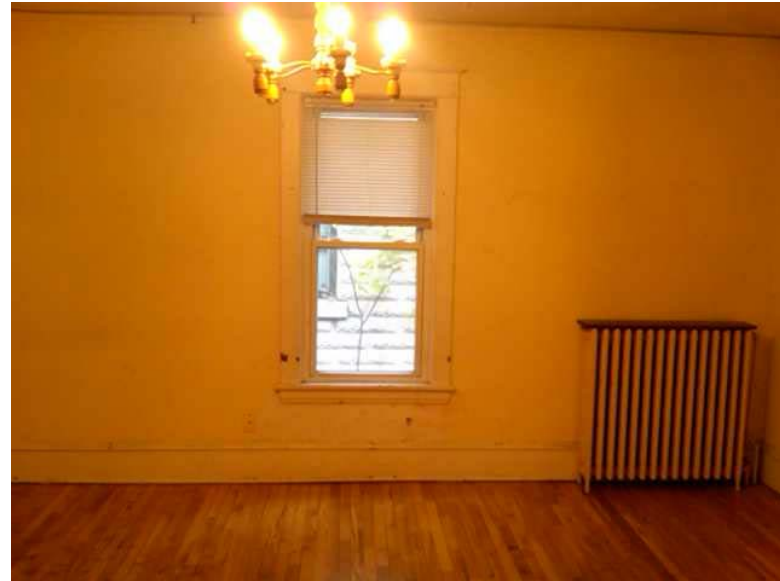
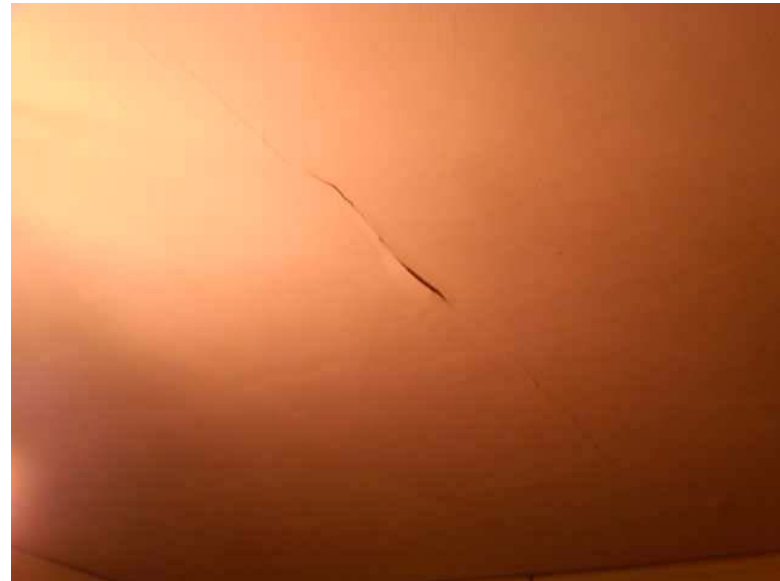
**8.10 INTERIOR**  
**Ceilings & Walls**

Lower Unit: Signs of leaking in ceiling at front wall (damaged plaster at ceiling).  
Upper Unit: Cracks in plaster walls/ceilings. Loose plaster, Chipped and peeling paint / stain. Patch work noted in areas.

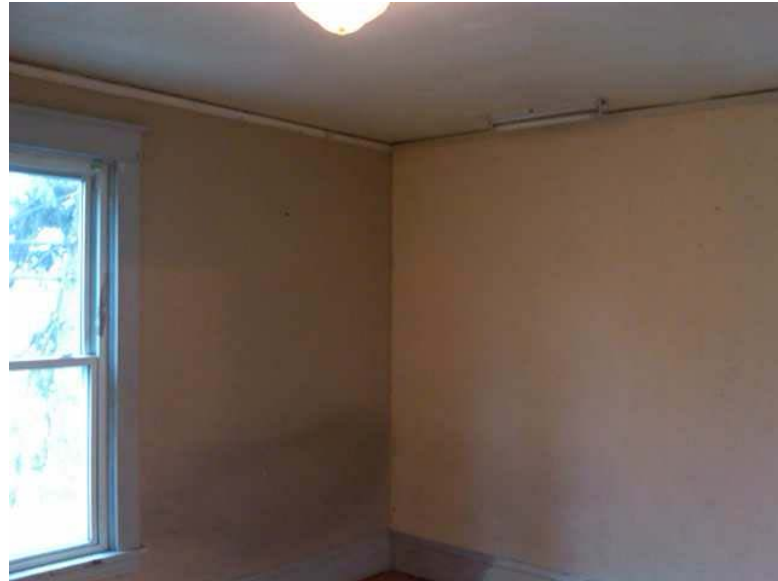
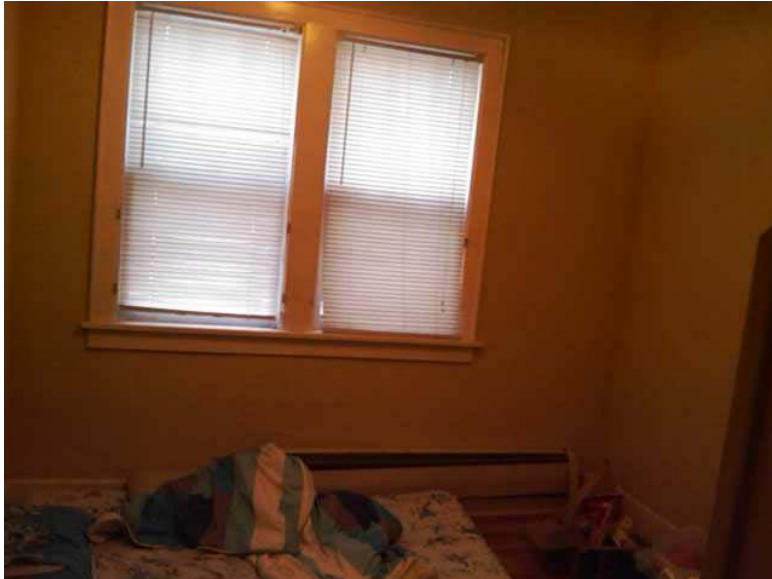
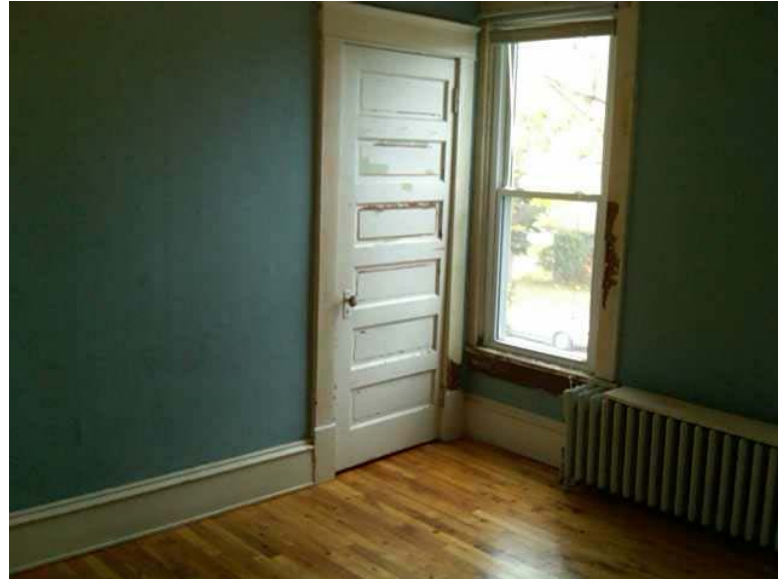
**8.15 INTERIOR**  
**Ceilings & Walls**

Lower Unit: Minor ceiling/wall deficiencies noted. Cracks in plaster walls/ceilings.

Upper Unit: Cracks in plaster walls/ceilings. Chipped and peeling paint / stain.

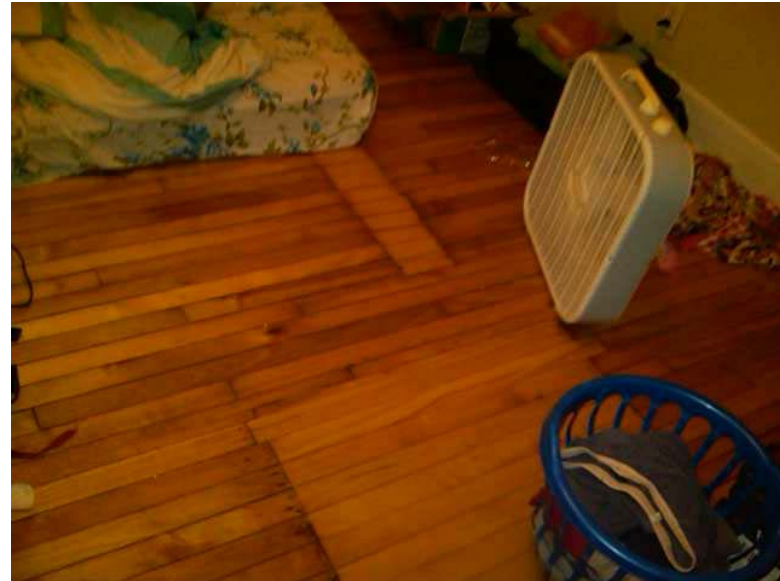
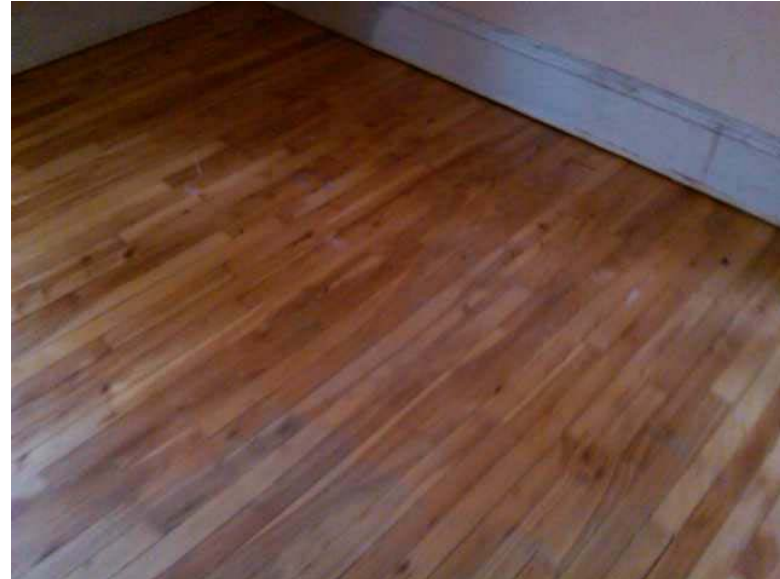
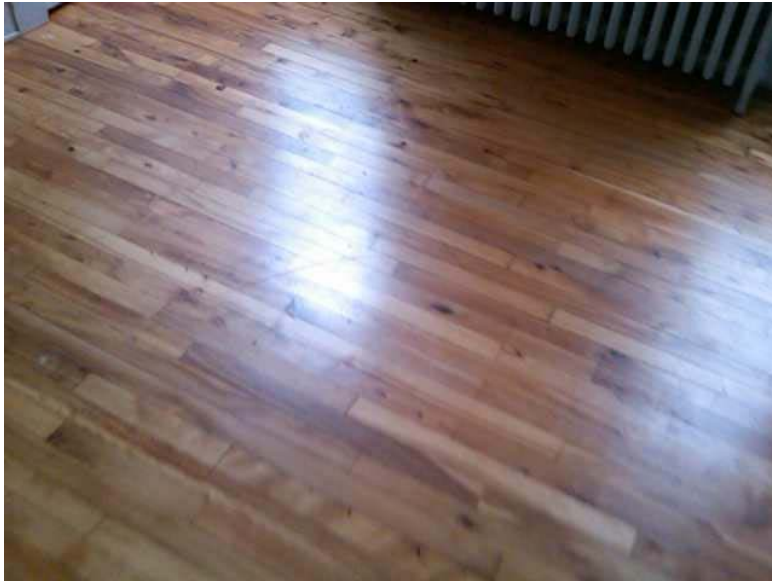
**8.16 INTERIOR  
Floors**

Upper Unit: Older flooring. Unlevel flooring. Surface wear to flooring in traffic areas. Worn hardwood floors.

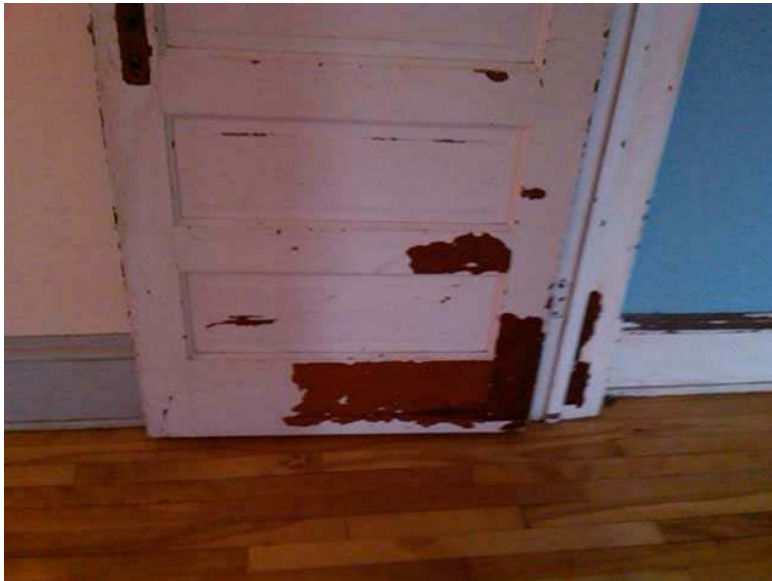
**8.17 INTERIOR - Bedroom(s)**

Some of the doors do not close and latch properly. Chipped and peeling paint.

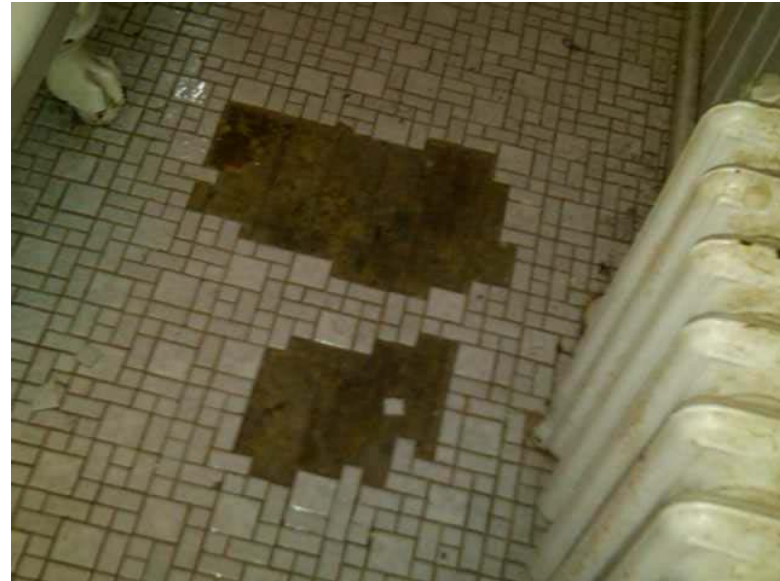
**8.21 INTERIOR**  
**Floors**

Lower Unit: Damaged and missing tile, Older flooring. Unlevel.  
Upper Unit: Damaged/loose and missing tile, decayed subflooring.

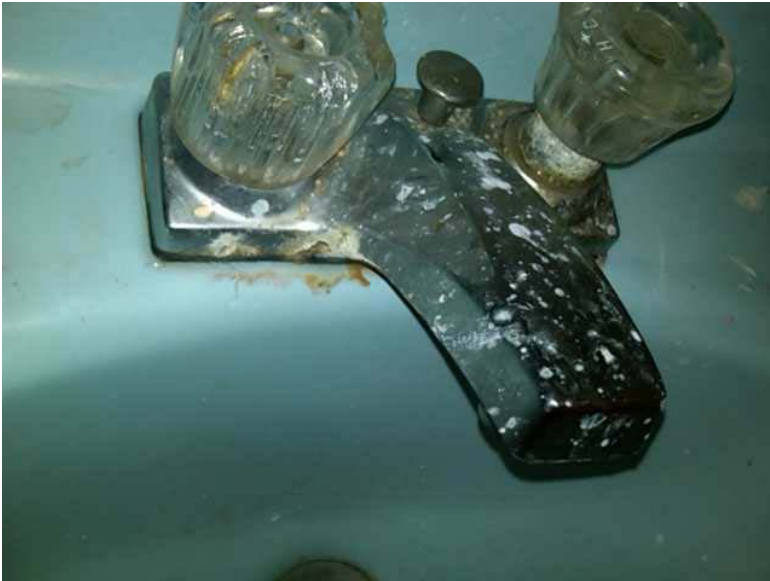
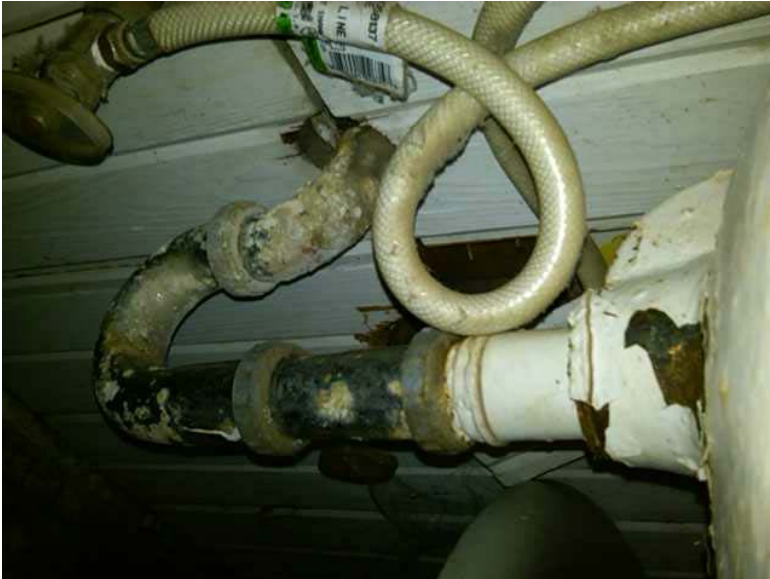
**8.25 INTERIOR - Bathroom(s)**

Lower Unit: Old corroded faucet, slight leak.

Upper Unit: Corroded drain piping.

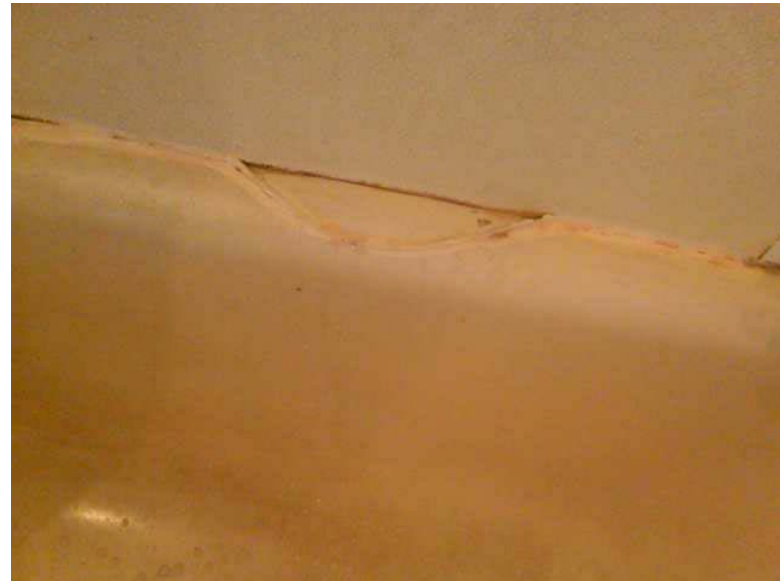
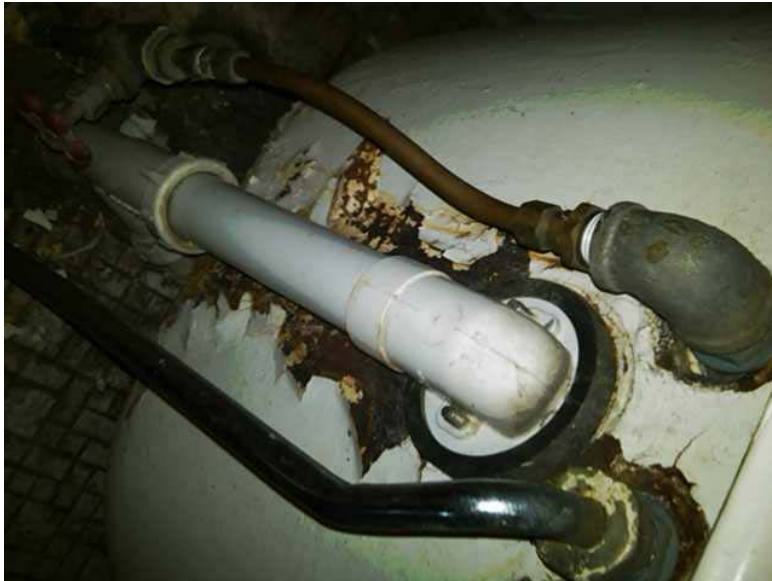
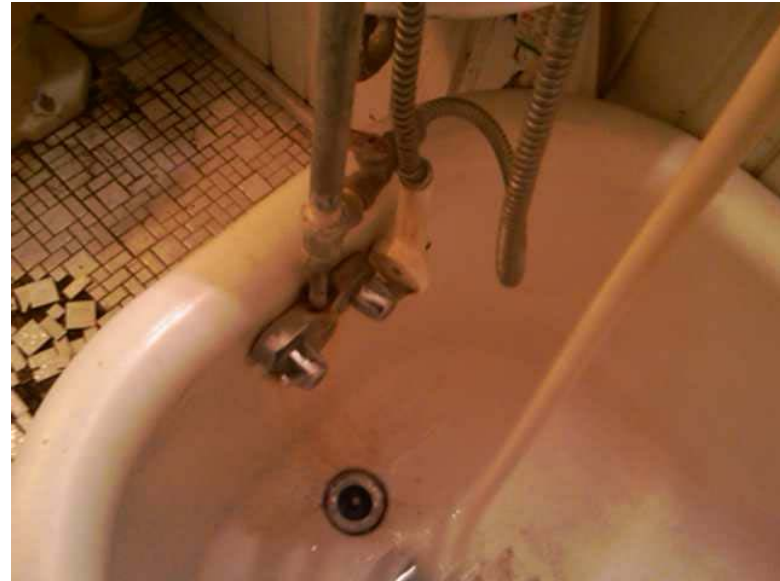
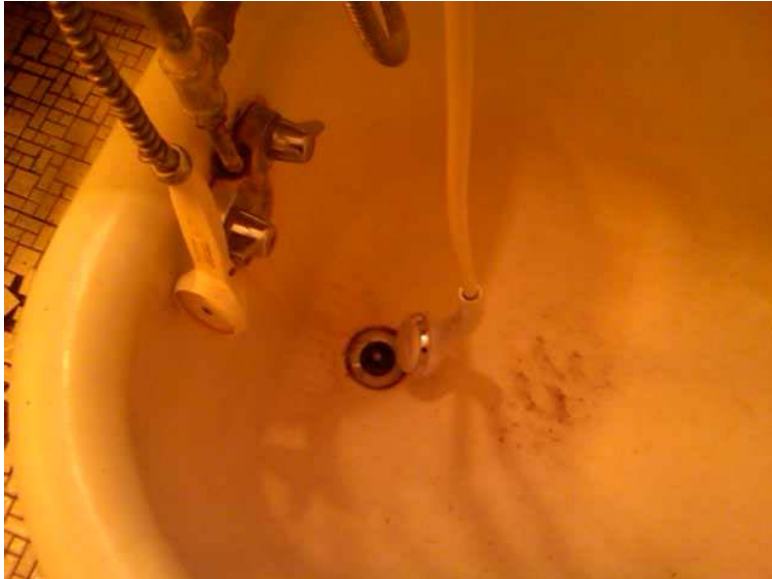
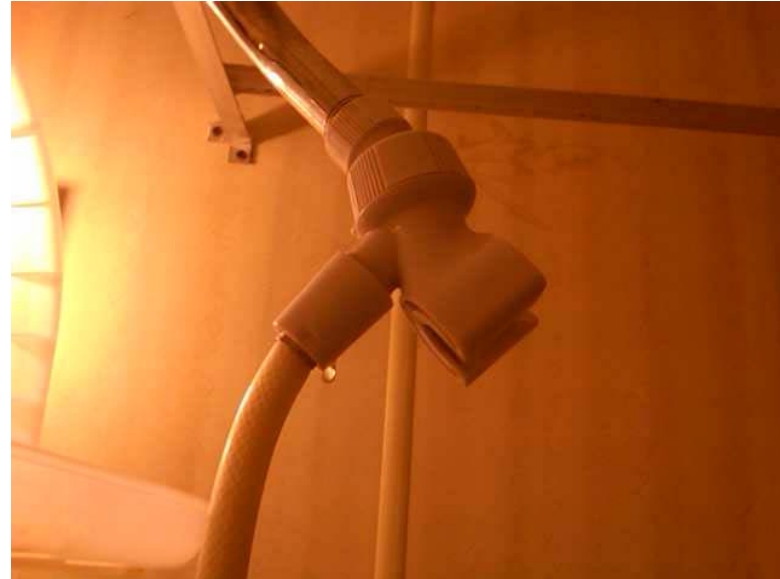
**8.26 INTERIOR**

Lower Unit: Some deteriorated grout/caulk. Missing tub stopper.

Upper Unit: Rusted and corroded tub on exterior, leak at shower wand connection, Shower wand extends below the spill line of the tub.

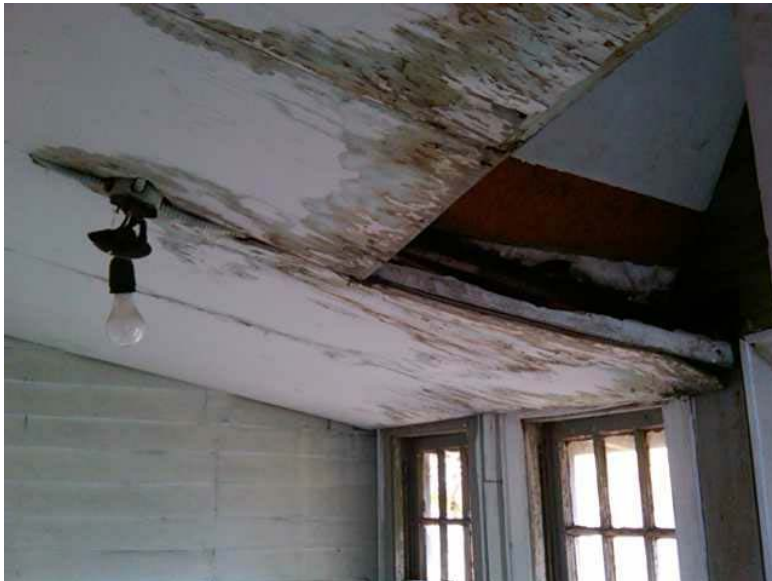
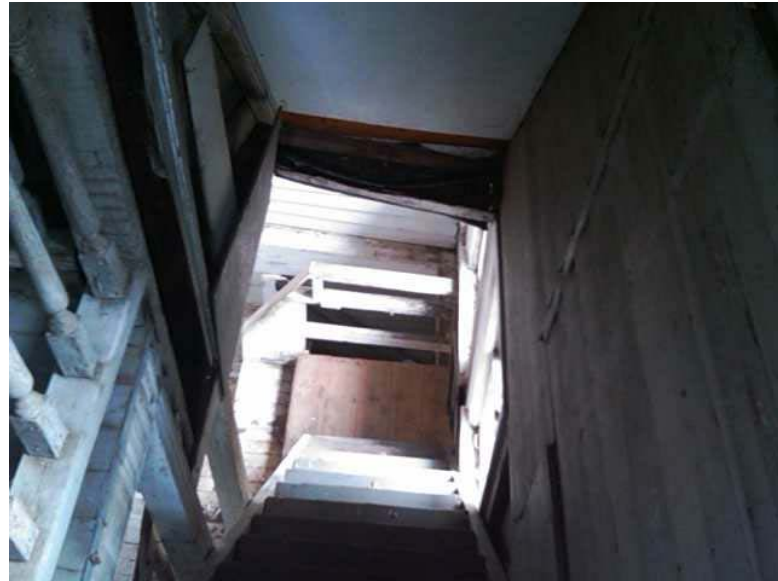
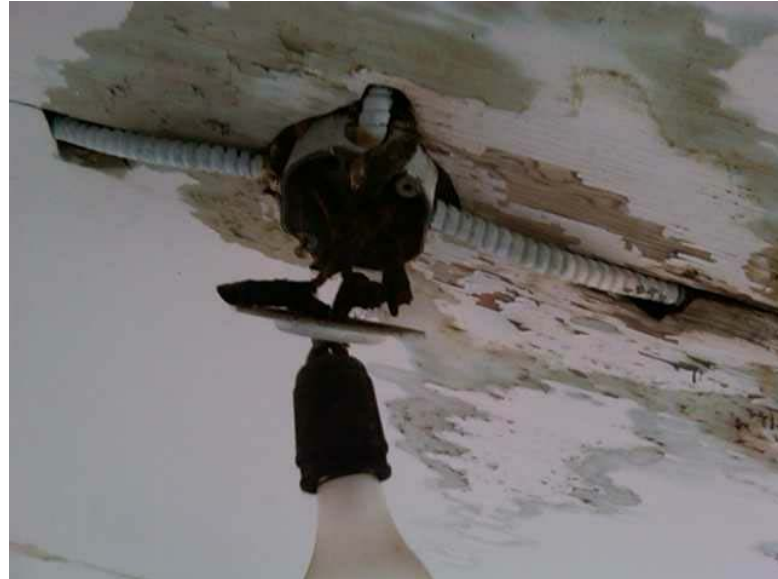
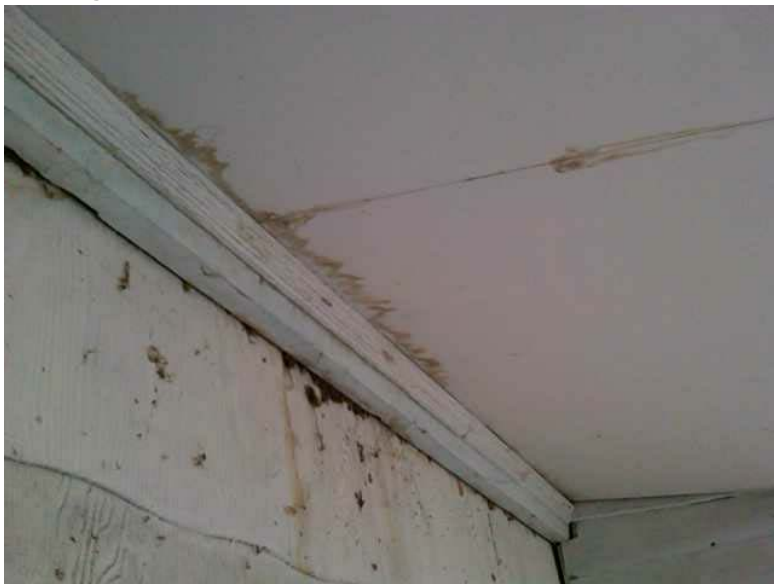
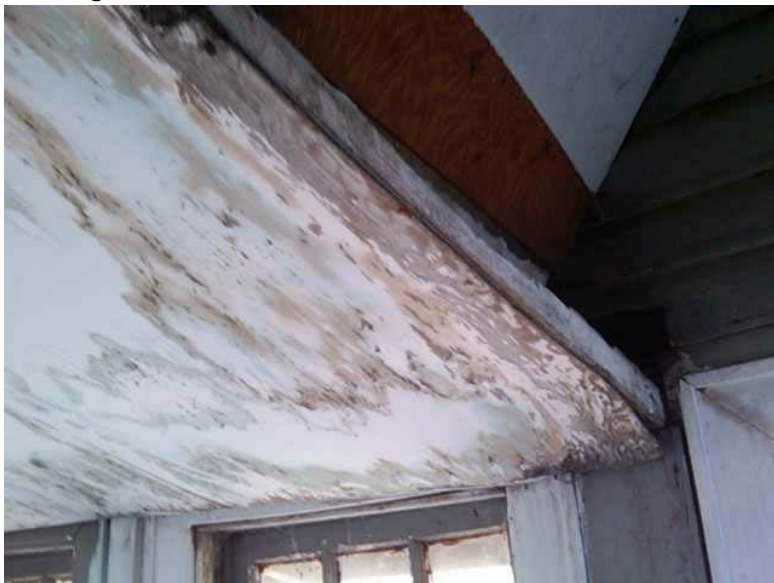
**8.31 INTERIOR**  
**Ceilings & Walls**

Lower Unit: Hole and stains in ceiling.

Upper Unit: Rear staircase - rotten roof structure, decayed wood, settled wood, moisture damaged ceiling components. Recommend consulting with a Licensed Contractor.

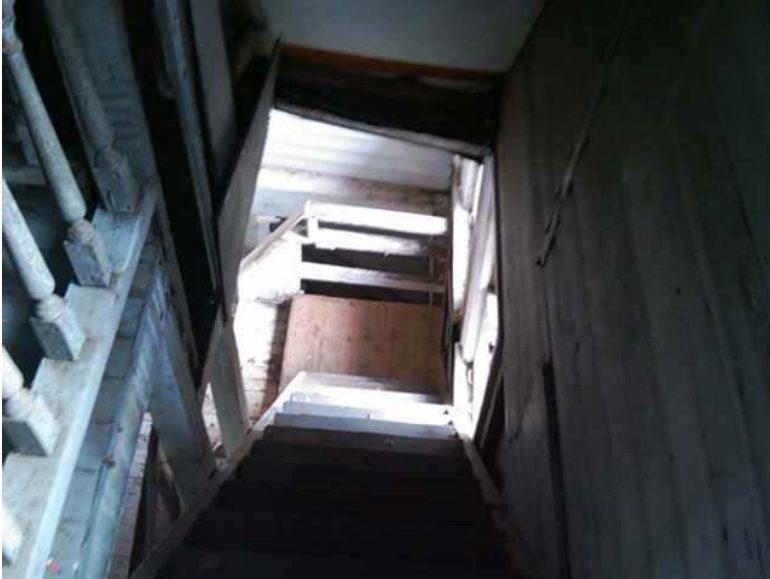
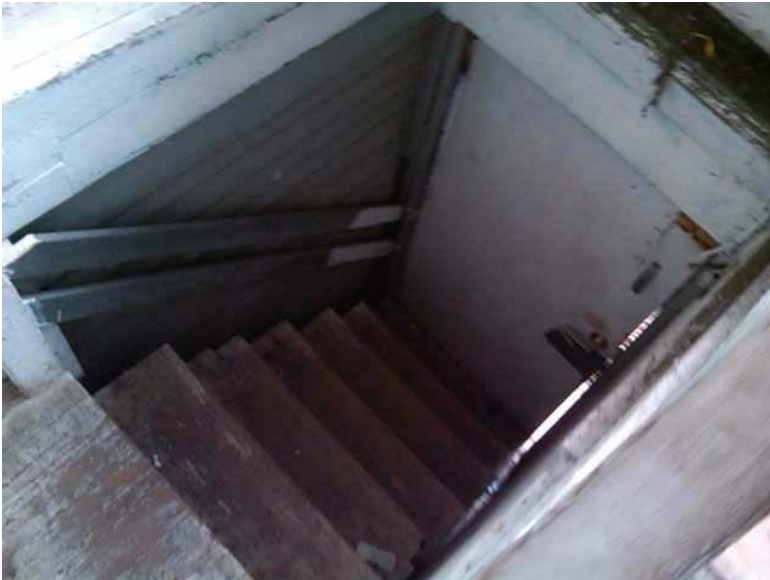
**8.35 INTERIOR**  
**Stairs & Rails**

Upper Unit rear staircase - sloped and settled staircase/structure, Lacks handrail(s). Headroom less than 6'8" high. Improper stair rise. Improper stair run. Front staircase - Lacks handrail(s). No railing/guardrail on open side of staircase. Headroom less than 6'8" high. Attic staircase - Lacks handrail(s). Lacks guardrail(s). Headroom less than 6'8"

high. Improper stair rise. Improper stair run.
